FIELD SERVICE BULLETIN

FSB Number	FLCCFSB2008 - 139/Rev1
Author	Guido Wuebbels
Date	Thursday, May 15, 2008
Subject	GSM - MOTOROKR U9 - BTB flex - open circuit
Model Affected	all
Level Of Repairs	3

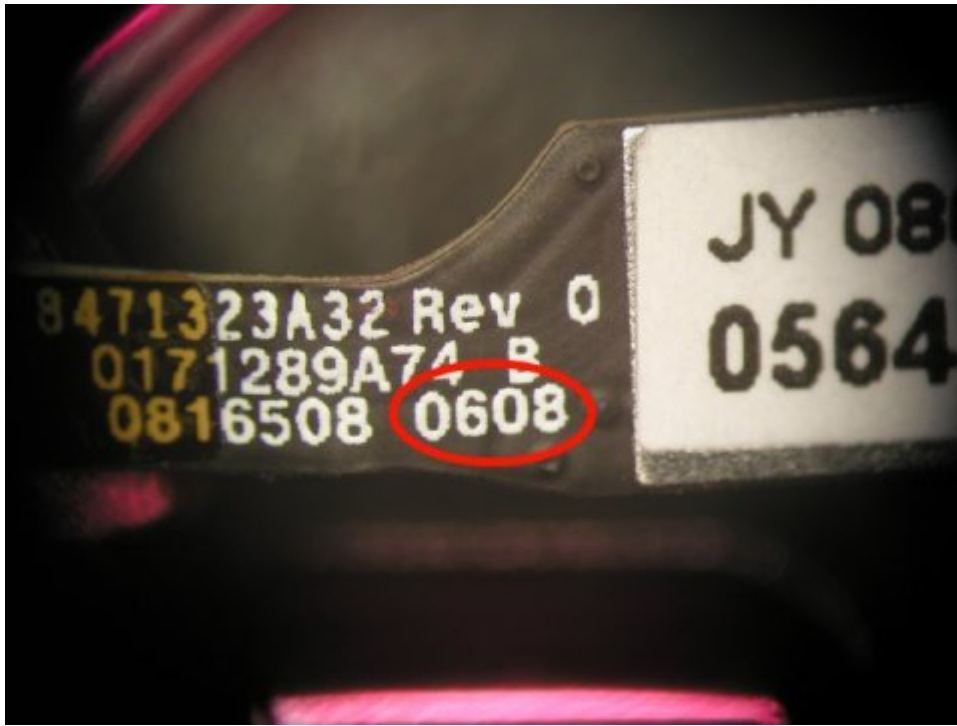
Figure 1: Date code identification

Root cause analysis showed that the Board-to-board Flex (Part number 0171289A74) is causing above listed issues. At least one Board-to-board (BTB) Flex line has no or only intermittent function due to an open circuit.

See Figure 1 below to identify date code information of the BTB flex. In the example in Figure 1, date code 0608 denotes week 06 in year 08.

please check if the issue is caused by a faulty Board-to-board Flex with date code before 4907 (use Figure 1 for reference). If this is the case: Replace BTB Flex (Part number 0171289A74) with a Flex part with date code 4907 or later.
