FIELD SERVICE BULLETIN

FSB Number	FLCCFSB2008 - 65
Author	Guido Wuebbels
Date	Monday, March 03, 2008
Subject	GSM - MOTOROKR U9 - Battery door does not fit
Model Affected	U9
Level Of Repairs	1

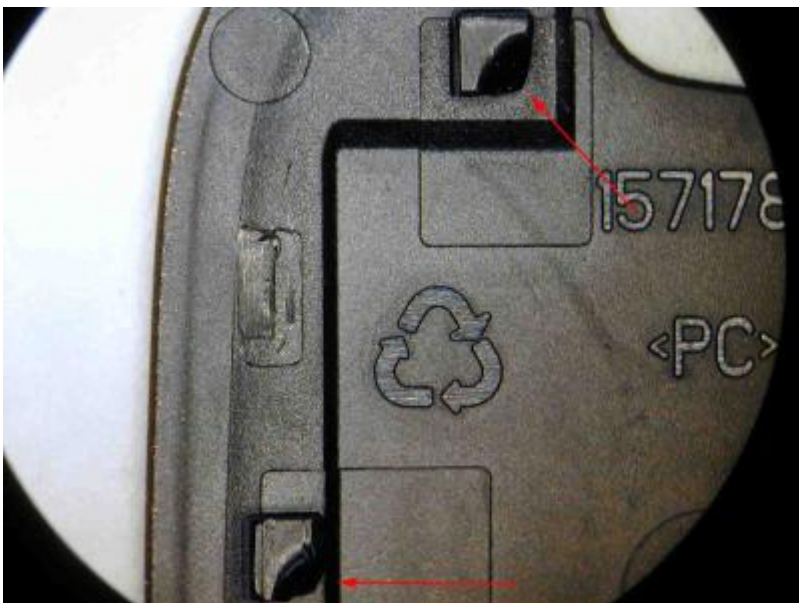
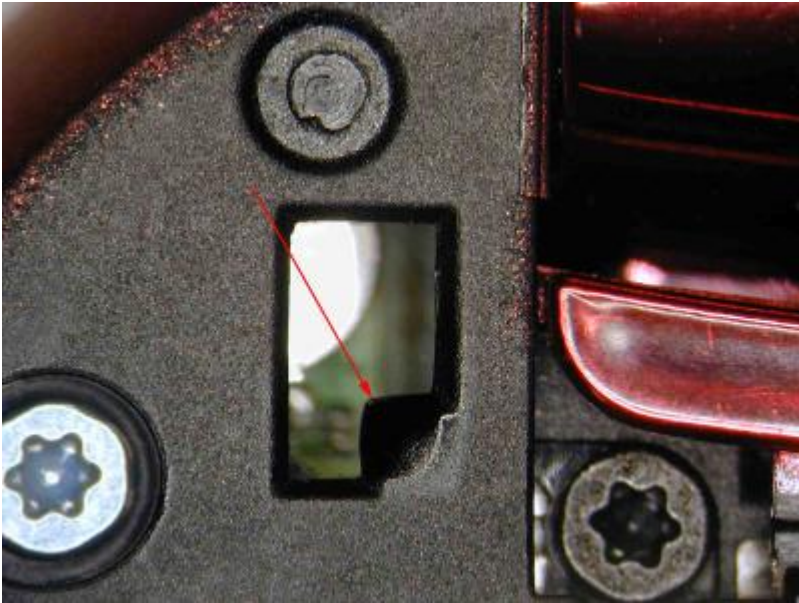
Service is aware that U9 units were returned during the NPI process with a customer complaint of "Battery door does not fit". The customer complained that it's difficult to insert the battery door. The root cause analysis reveals that the latch feature on battery door and rear housing were deformed, likely due to improper closing of the battery door by the end customer. The customer did not follow battery door closing instruction printed on the label on battery door bag and quick starter guide.

A label with instructions will be added on the top of the battery door. After first battery door insertion, the end customer will be able to remove this label.
