FIELD SERVICE BULLETIN

FSB Number LVCCFSB2007 - 369/Rev3
Author Tom Lee
Date Monday, March 03, 2008
Subject **GSM - Q700 - Resetting After Moving Slider Up and Down**
Model Affected Q700 (6.8 HW)
Level Of Repairs 2

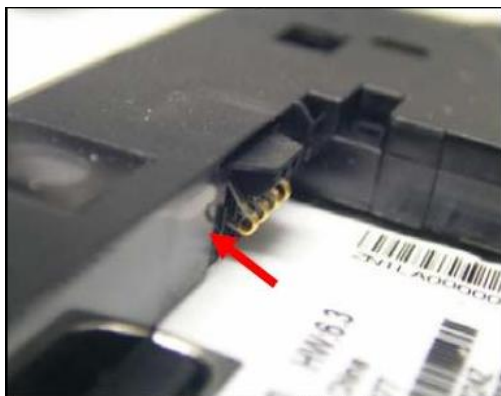
For all units with 6.8 HW, the user may see the unit power cycling after moving the slider up and down several times. The phone's battery contact block dimensions and foreign material on those contacts can contribute to this symptom.

MEZNT46001A
Battery block (old)
pins curling up (see arrow)

HW 7.1: newer battery contact block and rear housing. See Figs. 1-2 for illustration.

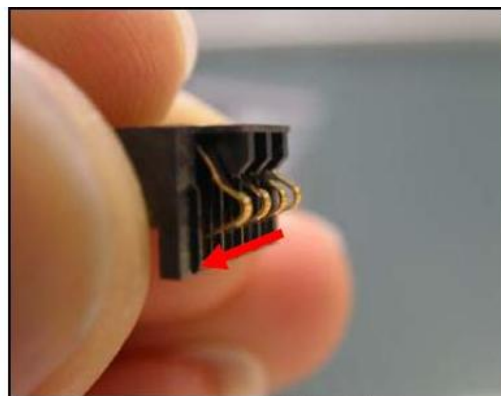
MEZNT46002B
Battery block (newer)
pins curling down (see arrow)

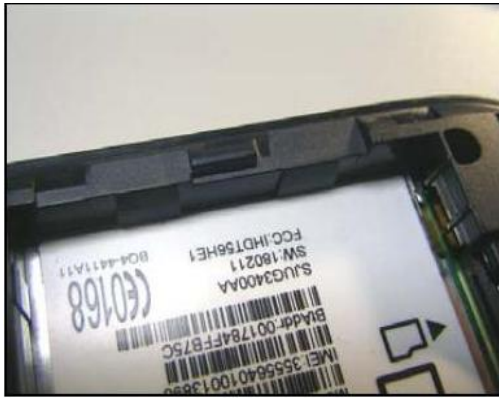
MEZNT61004B - old rear housing

- Replace the rear housing MEZNT61004B with rear housing MEZNT61004C (see Fig. 2 for illustration)
- If MEZNT61004C is unavailable, follow the mylar placement step below

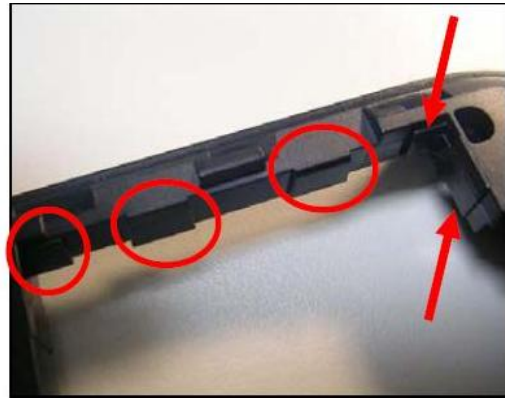
MEZNT61004C - newer rear housing
-added 2 ribs (see arrows)
-modified 3 ribs and made it bigger (see circles)

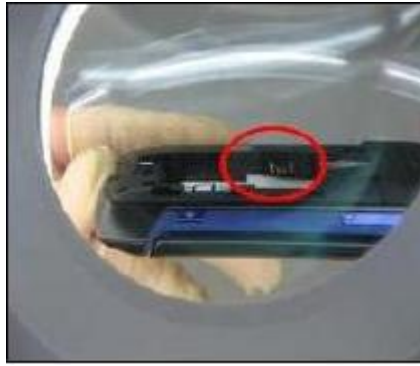
Figure 8 - Inspecting Battery Contacts with Magnifying Glass

- Inspect battery contacts with magnifier for foreign material on each unit. Note: Any foreign material is a fail, notify QA lead who logs the failure and takes appropriate action.

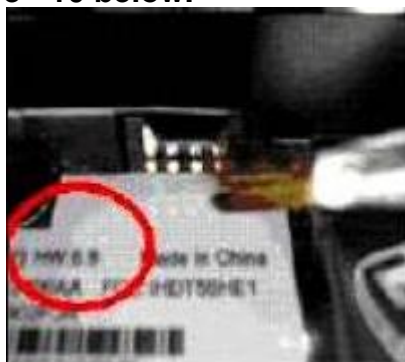
Figure 10 - Location of HW Version

1. All units with the HW 6.8 (Shipping Hardware Version) will need to be reworked (if not already; check the battery compartment for the mylar shims). Any HW version 6.9 or higher will already have the fix. See **Figure - 10 below**.
