FIELD SERVICE BULLETIN

FSB Number: LVCCFSB2005-230 (Rev B)
Author: Darwin Garcia
Date: August 18, 2005
Total No. of Pages: 3
Subject: **GSM Razr V3 SIM pin broken**
Model Affected: V3
Level of Repair: 3 & 4

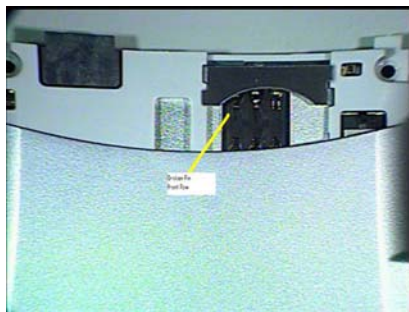
Service is aware that some V3 Razr units have been returned with complaints related to SIM detection. In several cases, service personnel have reported broken/bent pins in the SIM connector. The failure mode analysis indicates that the angle of insertion during SIM placement plays a fundamental role in the SIM connector damage.

Fig 1. A SIM Block pin in the front row is broken.

- 1.) Troubleshoot the unit following service standard procedures.
- 2.) If the SIM Block connector is damaged, replace it with a new SIM connector (PN: 3971332A02) if available if not use old SIM connector (PN: 39899888N01).
- 3.) Replace the rear housing with the redesign back cover (PN: 1590049N02 REV A/Silver, 1590049N03 REV A/ Black). **Note:** No new part numbers were issued for the rear housing with protective tabs. The corrective action was implemented as a running change at factory level and it will be fully implemented after the original rear housing available stock disappears.
- 4.) Test the unit for voice call performance.

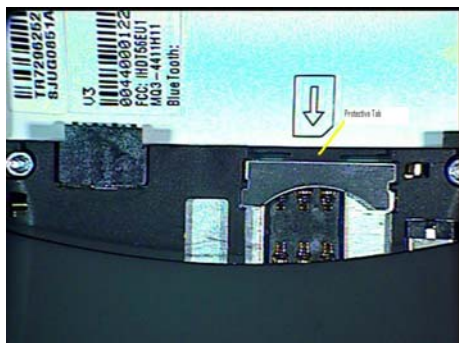
Fig 2. Housing with protective tab.

Short Term: A protective tab has been added to the back housing to prevent the user from bending or destroying the SIM connector front pins. The tab forces the SIM to run in parallel with the SIM connector's surface. The new rear housing was initially implemented at the factory in units built on black Razrs.
