## FIELD SERVICE BULLETIN

FSB Number: LVCCFSB2005-231(Revision A)  
Author: Amador Hassell  
Date: August 12, 2005  
Total No. of Pages: 4  
Subject: **GSM Razr V3 Hinge Broken**  
Model Affected: All Regions,  
Level of Repair: 1, and 2

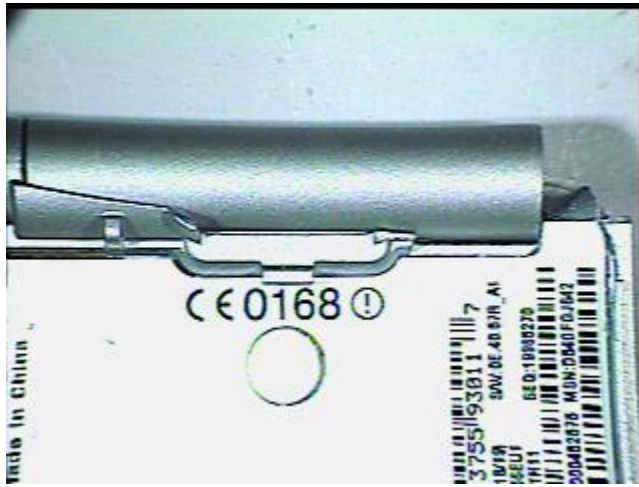
Service is aware that some V3 Razr units have been returned with complaints related to broken flip knuckles. The failure mode analysis has revealed that repeated impacts on the front housing knuckles (both, hinge and shaft) can weaken the knuckles and originate cracks. Frequently, the units have been returned after the users have dropped them on hard surfaces.

Fig.1. Cracked Knuckle

The front housing has been redesigned to include enhancing cross beams. The beams, placed in both knuckles, strengthen the cross section profile of the knuckles and reduce the deflection that causes the cracked knuckles.

1. Since the nature of the failure compromises the phones cosmetics, mark only the main board, the display assembly and the camera assembly for reuse.
2. Applying steps 10 thru 15 of the K-Flex repair procedure (LVCCFSB2005-93) rebuild the unit using the parts with the enhanced design. These parts are: Flip Inner (1590025N02/03 –Silver and 1590025N04/05 - Black), End Cap-Shaft (1589126Y01), End Cap-Hinge (1589127Y01), Front Housing Assembly (1590043N03/N04 -Silver and 1590043N07/N08 -Black) and Hinge Spacer (1587510Y01). Reuse the main board and the display assembly.

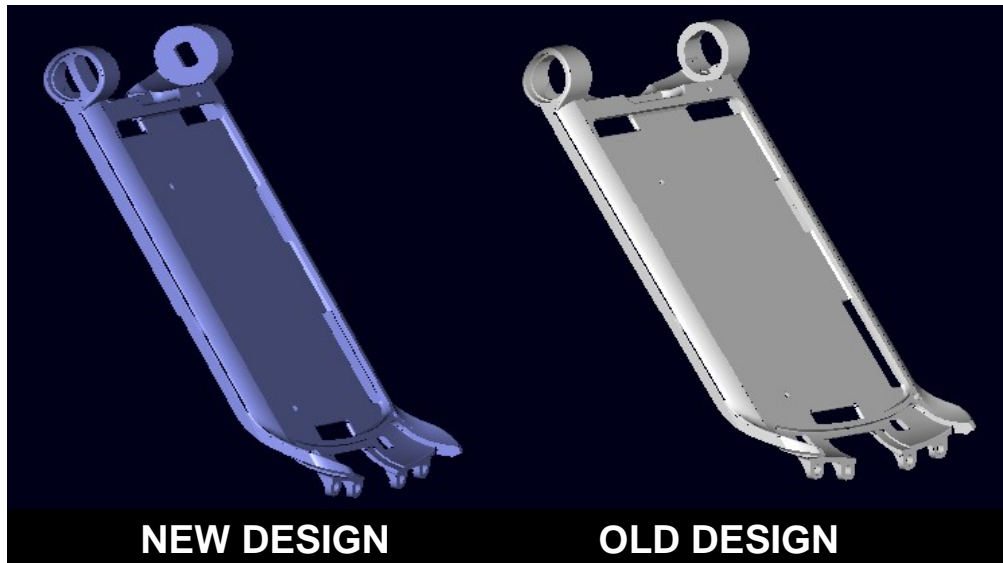
Fig. 2. Enhanced knuckles design.
