FIELD SERVICE BULLETIN

FSB Number: LVCCFSB2005-276
Authors: Darwin Garcia
Date: September 7, 2005
Total No. of Pages: 2
Subject: **V3 K-Flex Damage**
Model Affected: **V3**
Level of Repair: 3 & 4

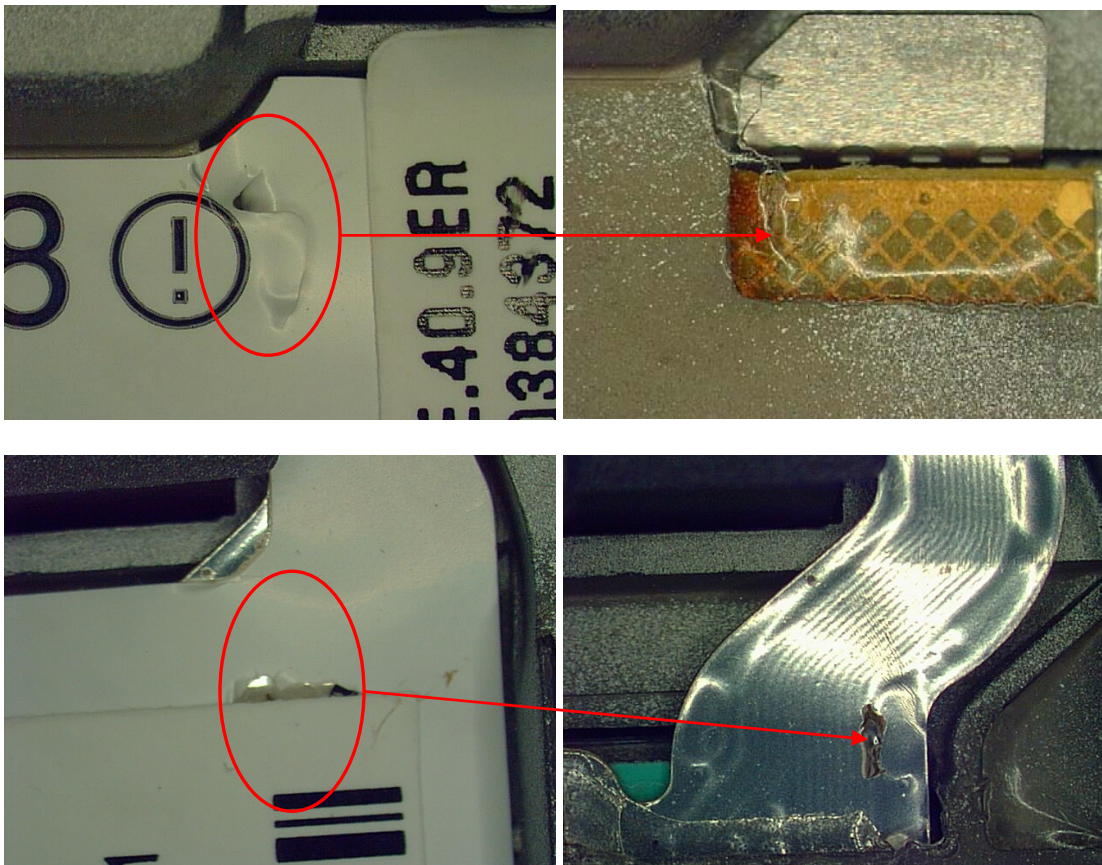
The root cause was determined to be tear/puncture of the battery compartment label through to the K-Flex due to the use of a tool (e.g. screwdriver), during battery removal. At this point it is unknown whether it occurred at a Motorola facility or from customer battery removal.

When servicing any V3 customer phones with described issue, the K-Flex must be replaced. Keyboard Flex Assy part# 8489976N03
See FSB LVCCFSB2005-93 for K-Flex repair instructions.
