FIELD SERVICE BULLETIN

FSB Number: LVCCFSB2005-286
Authors: Darwin Garcia
Date: September 12, 2005
Total No. of Pages: 2
Subject: **V3 Camera Module Insufficient Solder**
Model Affected: **V3**
Level of Repair: 3 & 4

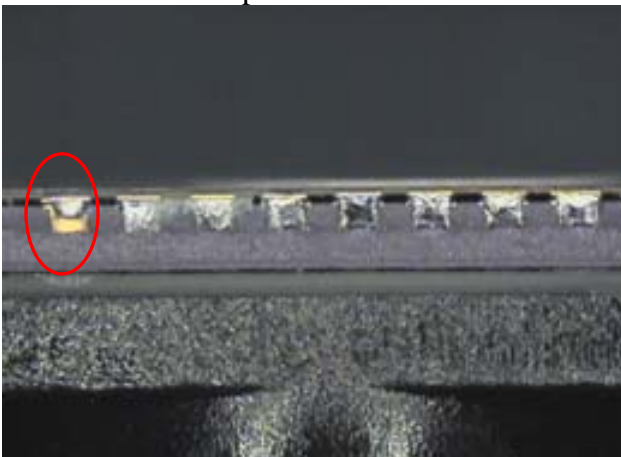
The root cause was determined to be soldering joint issue on the camera module caused by insufficient solder paste.

The Camera supplier modified stencil and solder paste for SMT process to improve solder quality and quality supervisors instructed operators to enhance solder insufficient symptom inspection. The corrective action was implemented on 8/24/2005, so all camera modules manufacture after date code TW0539 has the improvement.
