**FIELD SERVICE BULLETIN**

FSB Number: LVCCFSB2005-289  
Authors: Darwin Garcia  
Date: September 15, 2005  
Total No. of Pages: 3  
Subject: **V3 CLI ITO Corrosion WinTek**  
Model Affected: **V3**  
Level of Repair: 3 & 4

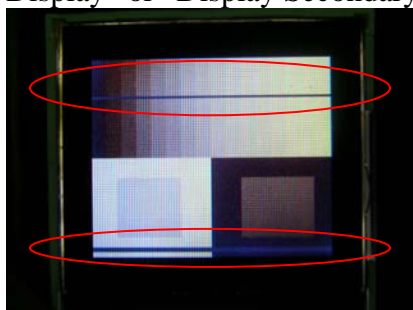
Service has been made aware of a V3 WinTek CLI ITO Corrosion Issue causing “No CLI Display” or “Display Secondary - Missing Pixels / Ico” complaints.

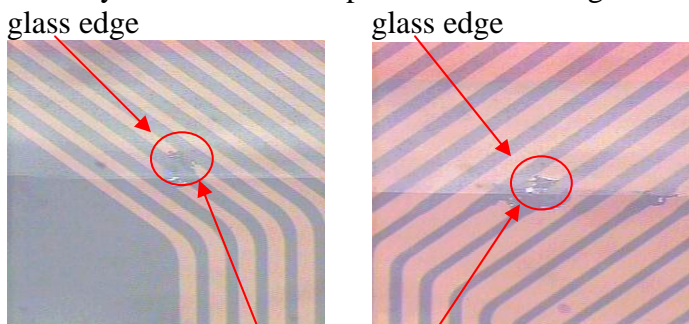
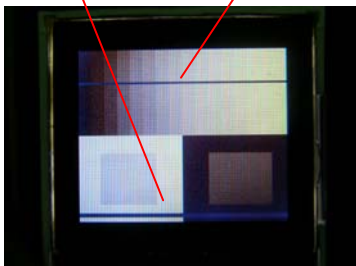
The root cause was determined to be corrosion on ITO circuits near the external cell gap and they are related to the positions of missing line.

A corrosion area      B corrosion area

After more in-deep analysis it was determined that the key factors that can cause ITO corrosion are the LCD cleaning and ITO exposure time.

1. Confirm the customer complaint
2. Replace the flip assembly if available with a known good one to ensure failure mode follows the flip.
  - a. If the failure mode does not follow the flip, then apply normal troubleshooting techniques to the PCB.
3. Disassemble the suspect flip assembly and replace the CLI Display Module with a known good one to confirm a CLI Display Module failure.
  - a. If the unit still exhibits the failure mode with a known good CLI Display Module, then apply normal troubleshooting techniques to identify the failed component.
4. Finally, replace the CLI Display Module with a date code of Week 05 '05 or later.
