FIELD SERVICE BULLETIN

FSB Number:	LVCCFSB2005-290
Authors:	Darwin Garcia
Date:	September 15, 2005
Total No. of Pages:	2
Subject:	V3 CLI FPC Inserting Deflective
Model Affected:	V3
Level of Repair:	3 & 4

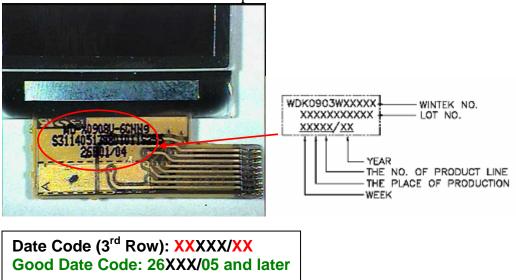
Service has been made aware of a V3 sub-CLI from Sanyo-Epson FPC insert issue causing "No CLI Display" complaints.

The root cause was determined to be the protective board of FPC on the Sub-CLI due to insufficient glue.

Supplier has changed material of glue to a more stronger adhesive. The corrective action was implemented on 6/26/2005, so all CLI modules manufacture after date code 26XXX/05 has the improvement.
