FIELD SERVICE BULLETIN

FSB Number: LVCCFSB2005-298
Authors: Darwin Garcia
Date: September 26, 2005
Total No. of Pages: 2
Subject: **V3 K-Flex 40 Pin Connector Engagement**
Model Affected: **V3**
Level of Repair: 3

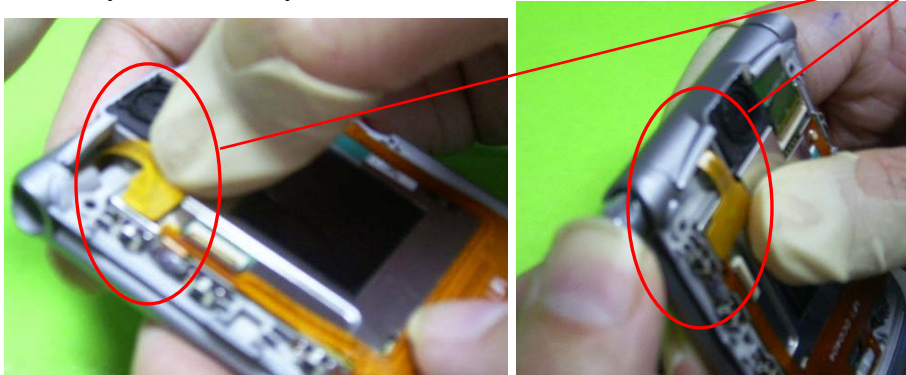
Service has been made aware of a V3 K-Flex 40 Pin Connector Engagement issue causing “No Display, and No Side key Function” complaints.

The root cause was determined to be the 40 Pin connector not being fully engaged during assembly at the factory.
