FIELD SERVICE BULLETIN

FSB Number: LVCCFSB2005-307
Authors: Darwin Garcia
Date: October 20, 2005
Total No. of Pages: 5
Subject: **V3 CLI Lens Replacement**
Model Affected: **V3**
Level of Repair: 2

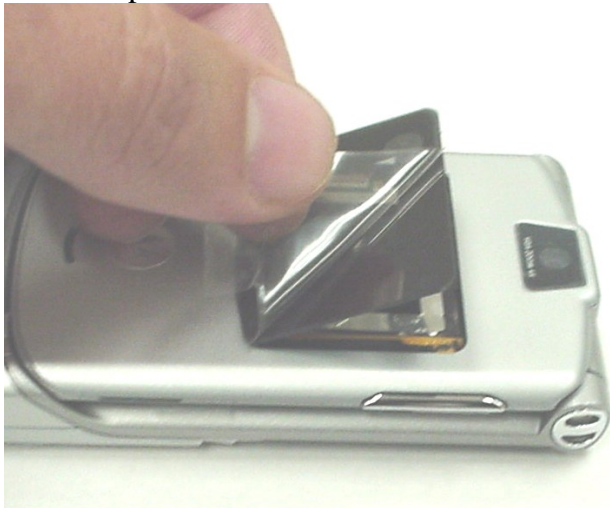
The EMEA service team has reported failure of CLI lenses coming loose 2-3 days after rework. As shown in the photograph, lenses pulled up from the flip when the protective liner was pulled.

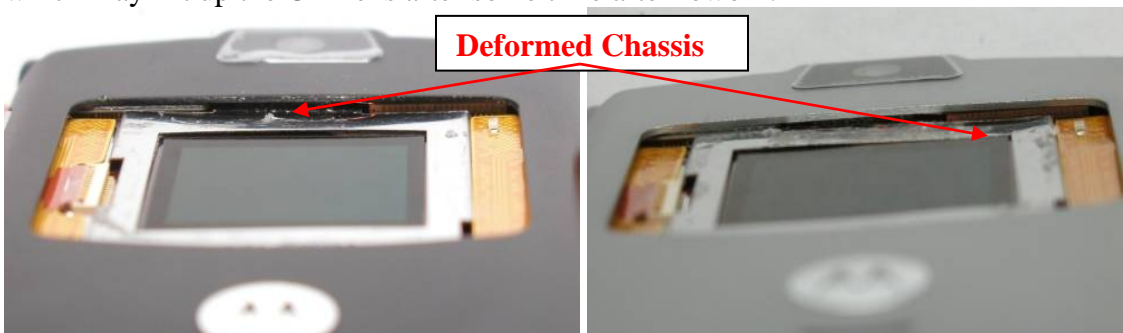
The root cause was determined to be the display chassis getting deformed when removing the old CLI lens from the phone at the service center. This causes a plate spring effect which may lift up the CLI lens after some time after rework.

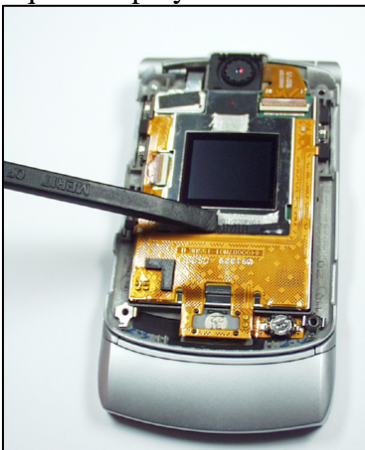
At Step 8, in order to maintain a flat working plane for the new LCD lens, care needs to be taken to lift the Lens as shown above. This will ensure the plane on which the LCD lens sits is not distorted. Distortion will cause the Lens to pop off.

8. Carefully remove the rest of glue in use of the plastic tool. Do not use any kind of liquid or spray!
