FIELD SERVICE BULLETIN

FSB Number: LVCCFSB2005-309
Authors: Darwin Garcia
Date: October 13, 2005
Total No. of Pages: 2
Subject: **V3 Flip Water Detect Labels**
Model Affected: **V3**
Level of Repair: 2

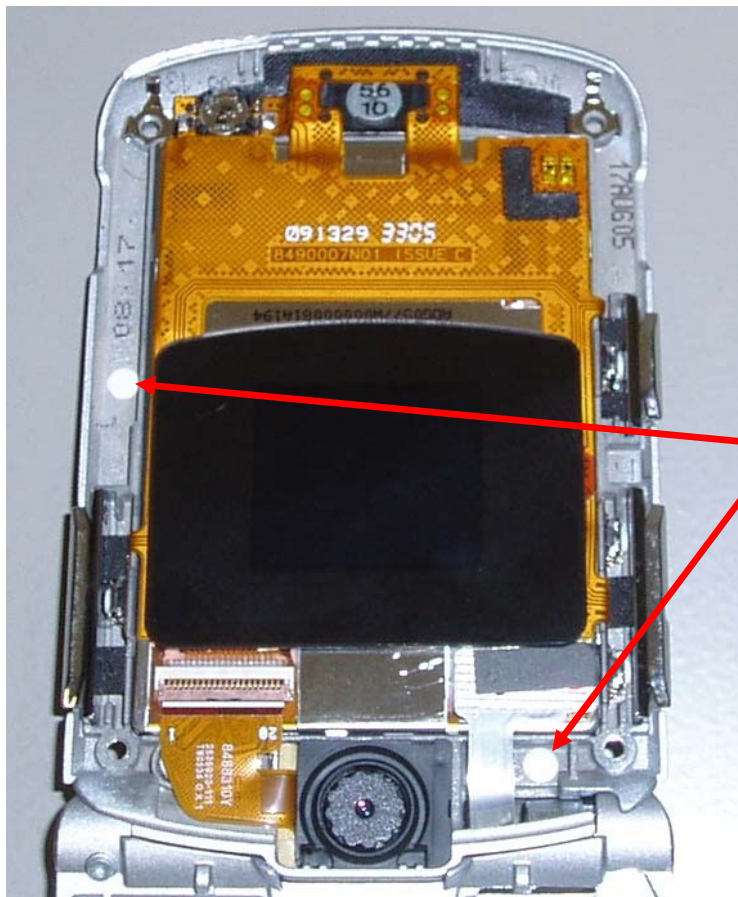
Two water detect labels to be placed as shown

These are NOT the same labels found on the PCB board and in the battery compartment.

Add the two 3mm water detect labels in repairs that required removal on the flip assembly.

Part Number: 5471536C01 (They are supplied by Fabritech)
