FIELD SERVICE BULLETIN

FSB Number: LVCCFSB2005-312
Authors: Darwin Garcia
Date: October 28, 2005
Total No. of Pages: 3
Subject: **V3 Torn P-Flex**
Model Affected: **V3**
Level of Repair: 2

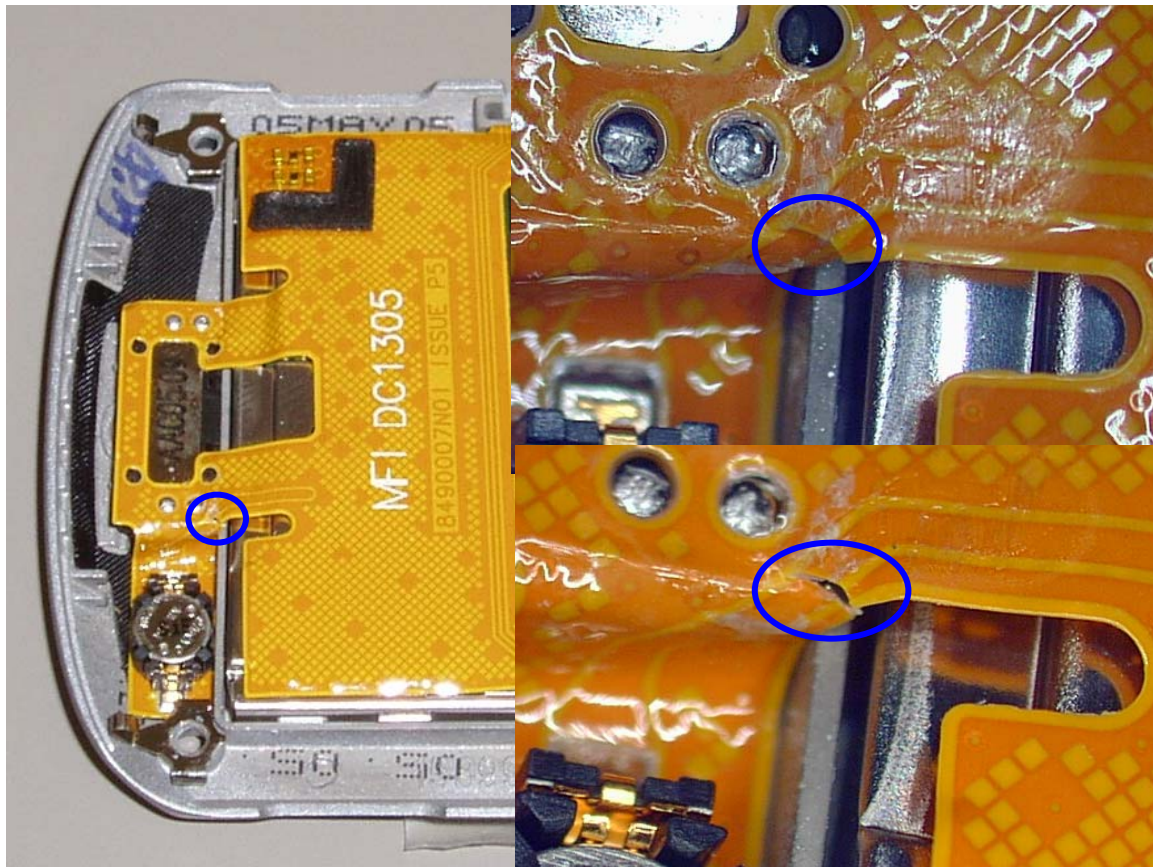
The root cause was determined to be a torn P-Flex near the earpiece speaker. In this unsupported area there is an opportunity for operator to touch this area when pushing down on earpiece speaker / RTC battery or when positioning the flip outer housing plastic hooks to torn the flex during the assembly process.

When servicing any V3 customer phones with described issue, the P-Flex must be replaced. Added care must be taken on this area of the P-Flex during the replacement.
Personality Flex Assy # 8490007N01

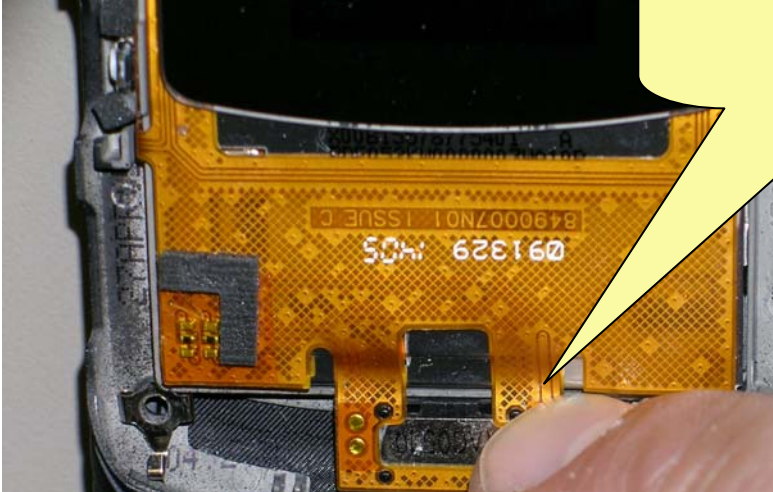
Operator finger tip opportunity to damage / puncture P-flex in this area.

- * With finger tip during Earpiece & RTC handling, and when pushing down to adhere adhesive backing.
- * During placement of flip outer housing, use caution not to touch flex in this area (with bottom side plastic hooks).

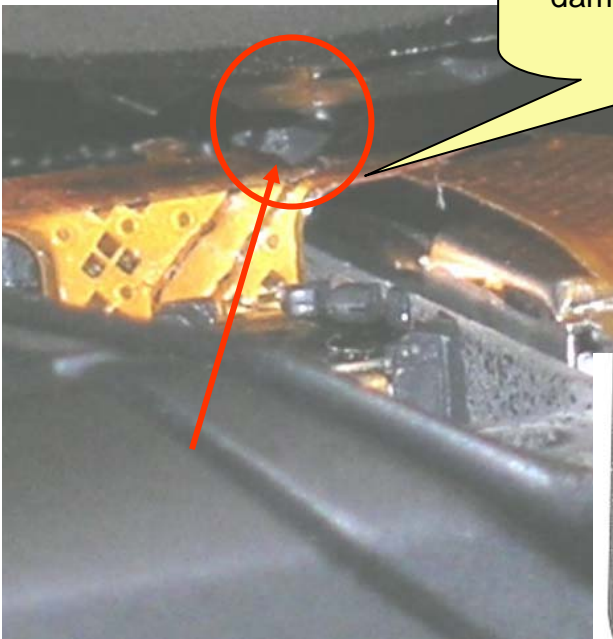
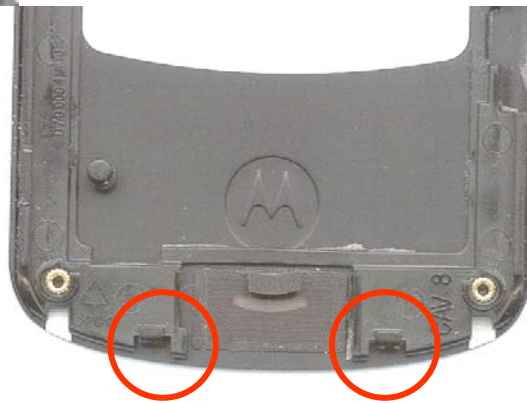
Plastic hooks on inside of flip outer have opportunity to damage / puncture P-flex in this area.
