FIELD SERVICE BULLETIN

FSB Number: LVCCFSB2005-368
Authors: Darwin Garcia
Date: December 15, 2005
Total No. of Pages: 2
Subject: **V3 CLI Crack Driver IC**
Model Affected: **V3**
Level of Repair: 2

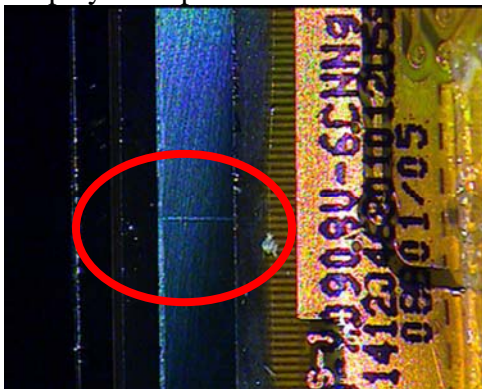
Service has been made aware of a V3 CLI crack driver IC issue causing “No CLI Display” complaints.

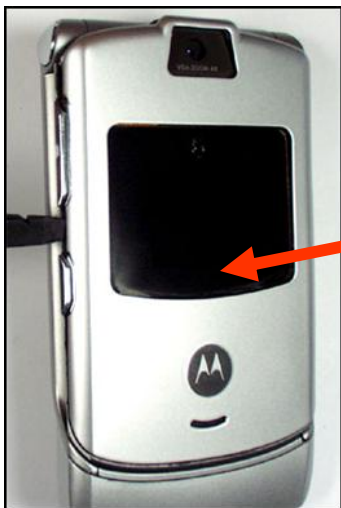
Point of Impact

The cause of the crack driver IC was determined to be physical force being applied at the CLI lens.
