### **FIELD SERVICE BULLETIN**

FSB Number: LVCCFSB2006-136  
Authors: Darwin Garcia  
Date: April 7, 2006  
Total No. of Pages: 2  
Subject: **V3 P-Flex Corrosion**  
Model Affected: **V3**  
Level of Repair: 2

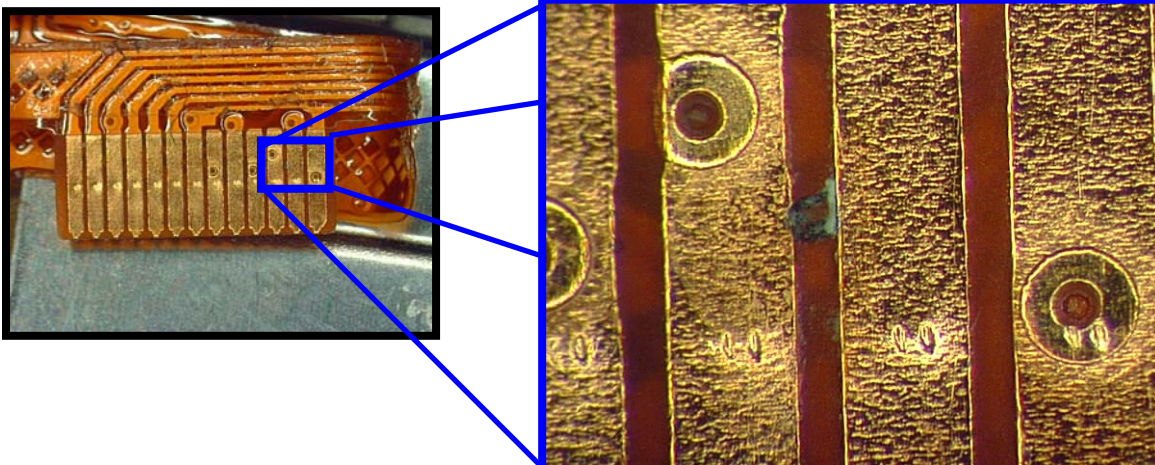
Service has been made aware of a V3 P-Flex corrosion issue causing “Main Keypad - No function/ hangs & Side Keys - No function” complaints.

The root cause was determined to be contamination between gold fingers of P-Flex introduced by the masking process during manufacturing at the supplier.

When servicing any V3 customer phones with described issue, the P-Flex must be replaced. Personality Flex Assy # 8490007N01
