FIELD SERVICE BULLETIN

FSB Number: LVCCFSB2006-137
Authors: Darwin Garcia
Date: May 8, 2006
Total No. of Pages: 2
Subject: **V3 Noisy Knuckle**
Model Affected: **V3**
Level of Repair: 2

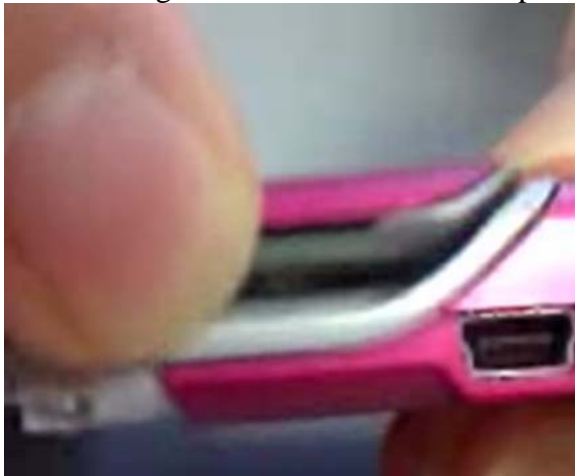
The EMEA service team has reported V3 noisy knuckles issue after K-Flex replacement. This clicking noise can be heard when opening the flip.

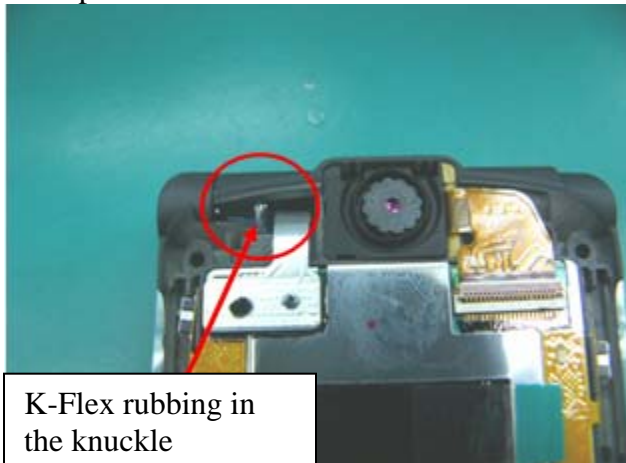
The root cause was determined to be the K-Flex rubbing in the knuckle creating this clicking noise; this was due to service center not applying grease to the endcap during repair. The factory assembly procedure calls for grease to be applied to the shaft side endcap.

K-Flex rubbing in the knuckle

Is recommended that service center add grease to the endcap.
