## FIELD SERVICE BULLETIN

FSB Number: LVCCFSB2006-231  
Author: Tony Bryan  
Date: June 26, 2006  
Total No. of Pages: 2  
Subject: GSM RAZR – Distorted Alert Audio (Grommet Misassembled)  
Model Affected: GSM RAZR V3, V3i, V3-05  
Level of Repair: 2

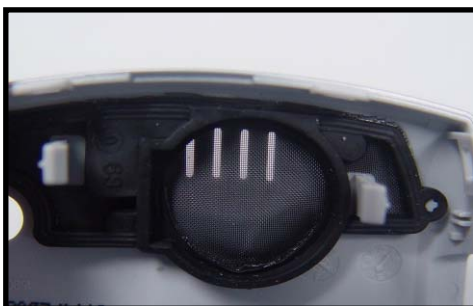
Figure: 1.0 – Alert Grommet / AW

Service is aware of an issue identified during NPI analysis of GSM RAZR V3-05 phones. Some units, returned with customer complaints of “Alert – Ring tone, noise/distortion”, were found to have distorted audio during the playback of certain ring tones. The cause of distortion was determined to be improper assembly of the alert grommet acoustic screen (3587321Y01). The acoustic mesh was buckled which interfered with the excursion of the diaphragm at lower frequencies.

Supplier FoxConn has modified the SOP and provided operator training on use of the required fixture to assist in the placement of the Alert Grommet. Increased inspection for buckled mesh has implemented in-line and at QA. – 5/7/2006

1. Verify the customer complaint by confirming distorted audio during the playback of certain ring tones.
2. Disassemble the unit and inspect the alert grommet acoustic screen (3587321Y01) for proper placement, replace if misassembled.
  - a. If the alert grommet acoustic screen is assembled correctly, then proceed with normal troubleshooting to determine the problem, per the customer complaint.
3. Reassemble the unit, and verify that customer complaint is fixed.
  - a. If the unit still displays the original failure symptom after repair, then follow normal troubleshooting and repair techniques to repair the phone, per the customer complaint.
