INFORMATIONAL FIELD SERVICE BULLETIN

FSB Number: LVCCFSB2006-320
Authors: Darwin Garcia
Date: July 20, 2006
Total No. of Pages: 4
Subject: **Flip Liquid Detect Label Falsely Trigger**
Model Affected: **V3, V3_05**
Level of Repair: 2

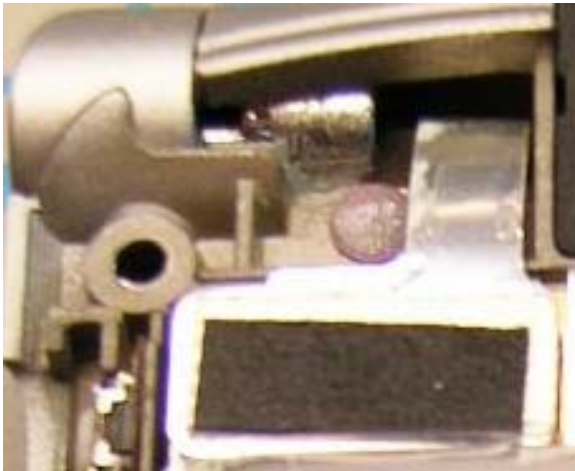
The NA service team has reported an issue V3 flip liquid detect label being false trigger by the grease applied on the end cap. When the grease trigger the liquid detect label it will slowly (over 24hr) turn to a brown color instead of the common red when trigger by other liquids.

Trigger by grease. (Brown)

The root cause was determined to be excessive amount of grease applied to the end cap and consequentially contacting the liquid detect label during manufacturing and repair/refurnish.

The factory improved their grease applying process by changing the placement procedure and using an injector to control the amount. Implemented on June 23rd.

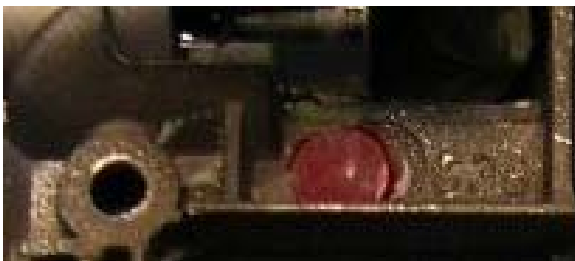
Trigger by water. (Red)

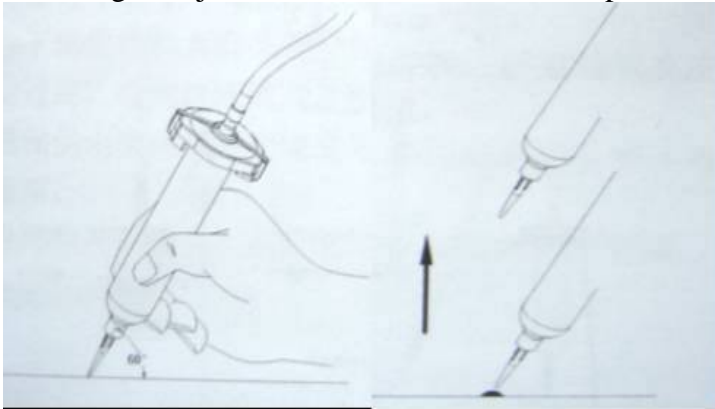
Placement angle of 60 degrees

Injector

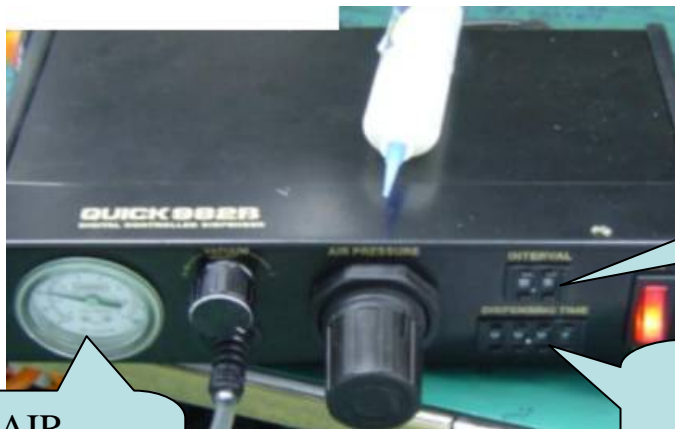
Injector setting

AIR PRESSURE:
0.20—0.22

INTERVAL:
0.1-0.2s

DISPENSING TIME: 0.05—0.09s
