FIELD SERVICE BULLETIN

FSB Number: LVCCFSB2006-004 (Rev A)
Authors: Darwin Garcia
Date: January 10, 2006
Total No. of Pages: 2
Subject: **V3 Display Audio Buzz in STBY (Informational)**
Model Affected: **V3, V3c**
Level of Repair: 1

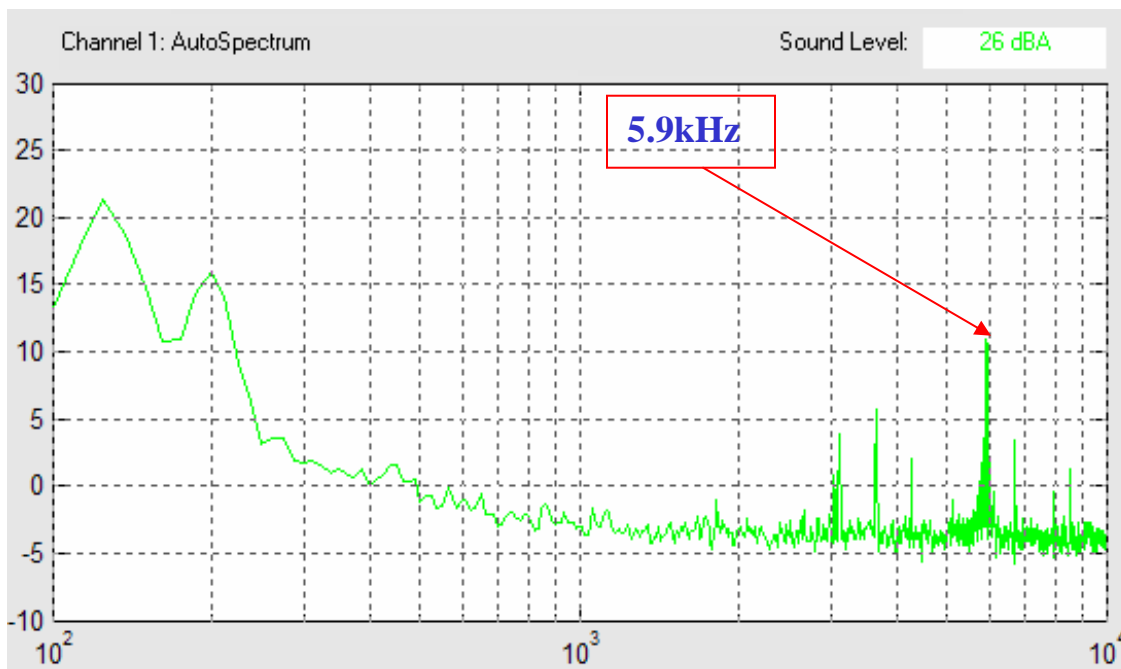
Service is aware that some customers have raised concerns about “audio buzz” heard emanating from the display. This audio buzz is directly related to the line inversion frequency of the display glass causing it to vibrate, which uses a 2.3MHz pixel clock that is audible at 5.9kHz in standby mode.

There are two factors that make this symptom happen:

1. Gate Electrode.
2. Source Electrode.

In the current design when the two electrodes are at high peak level of Freq, it will cause the glass panel start to vibrate therefore becoming like a speaker and emanating the high pitched noise, which at the display module level is acceptable.

Currently there is NOT a solution or design changes available for the display module or for the flip assembly.

Note: The alternative is switching the display module to refresh the main display from line inversion to frame inversion mode will eliminates the high pitched noise but unfortunately, it will deteriorated the display performance introducing major issues such as flickering, grey background, etc. **This will not be pursued.**

Note: Replacement of the display module or the flip assembly is **NOT** recommended.

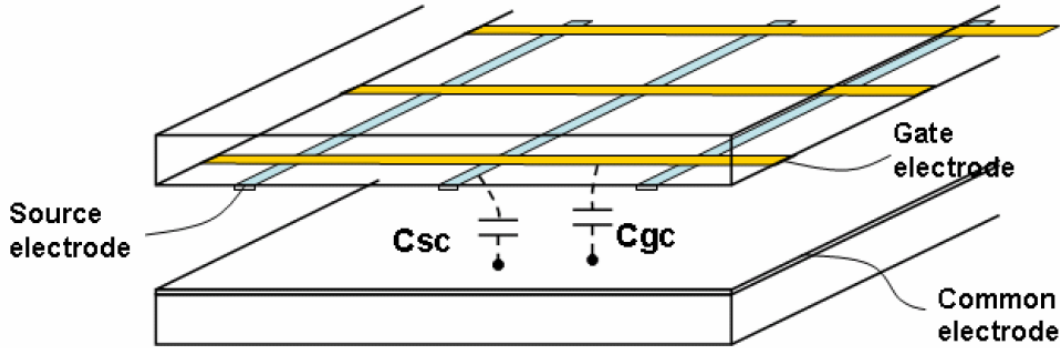
2. Buzz noise issue

→ LCD panel is vibrating by COM driving voltage because of its construction, and becomes like a speaker.

Vibration is caused by the force that common electrode and Gate/Source attract together.

However due to the thickness constrain of the flip assembly when the display module is assembled, the glass hits the hard surface of the inner parts and in some cases amplifies the high pitched noise.
