FIELD SERVICE BULLETIN

FSB Number: LVCCFSB2006-83
Author: Tony Bryan/Darwin Garcia
Date: March 10, 2006
Total No. of Pages: 9
Subject: GSM RAZR V3 & RAZR 05 – Toko Hall-Effect Switch
Phone Models: GSM RAZR V3, RAZR 05
Level of Repair: 2

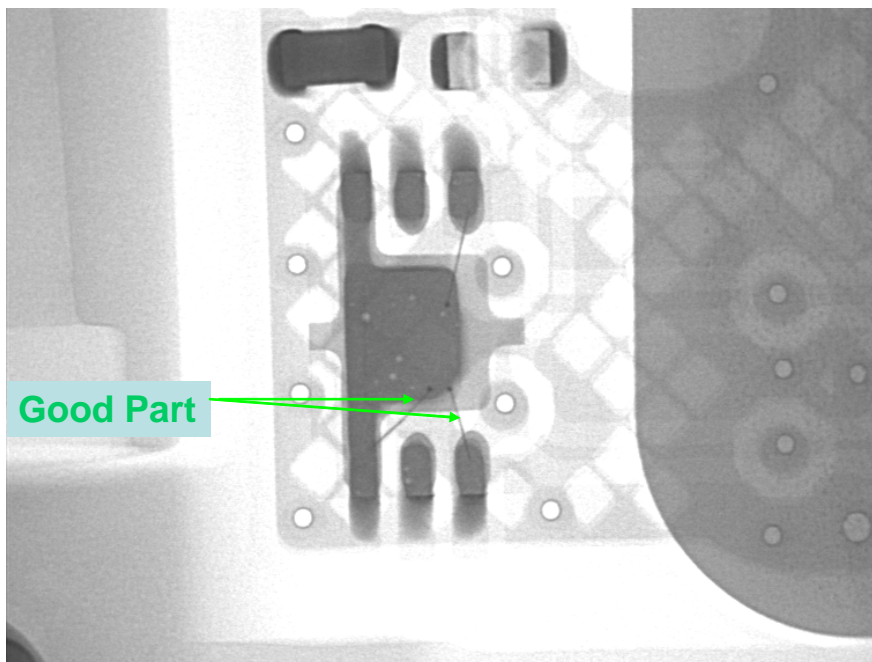
Hall Diode : "Allegro" Part

Phones are checked using an X-Ray equipment. Although at this level there are no visible differences between a XCVR with Toko or Allegro parts, there are differences in wire bonding. These can be seen via x-ray as detailed in the images below.

The distance of two wires is shorter.

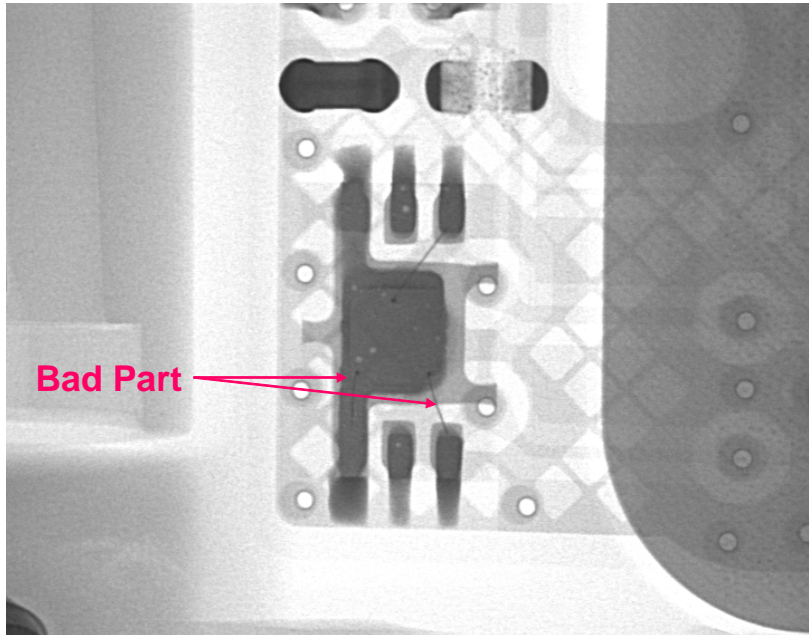
Hall Diode : "TOKO" Part

The distance of two wires is bigger.

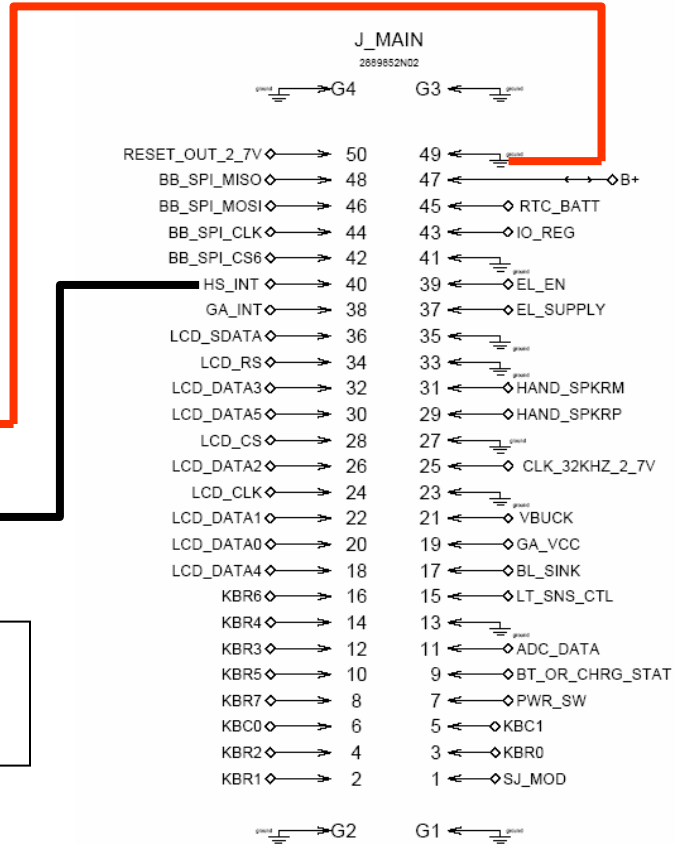
Flips can be sorted by measuring switch resistance. Measure the Hall-Effect switch resistance to separate the Allegro part from TOKO parts, different supplier part has different resistance.

Allegro Part - Resistance Measurement less than or equal to 43.5 kOhm (Allegro Nominal Value = 39.8 kOhm)

Toko Part – Resistance Measure greater than or equal to 44 kOhm (Toko Nominal Value = 51.4 kOhm)

The positive probe connect Ground pin and
 the negative probe connect Hs-INT pin.
 The resistance measurement range to set to
 AUTO.

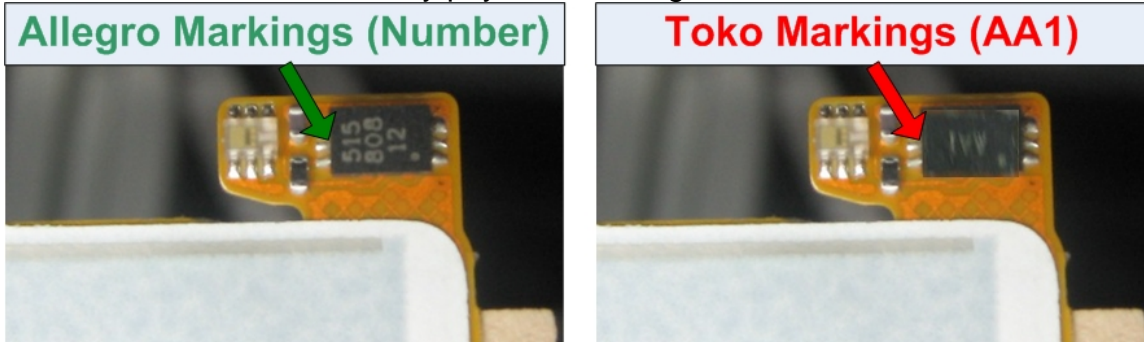
K-Flex can be sorted by physical marking on the hall-effect switch.

K-Flex built with both vendors range of date codes.

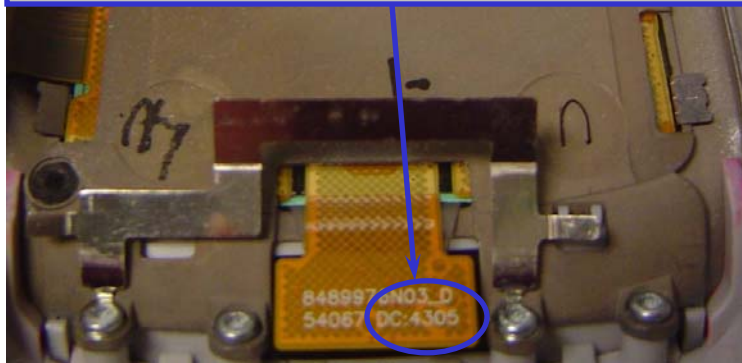
Date Code Ranges: 5105 to 0806
 K-Flex Supplier ID: Nwing = 091329 & MFlex = 54067
