Field Bulletin

V3 GP Gate Issue

Ref: UKE022

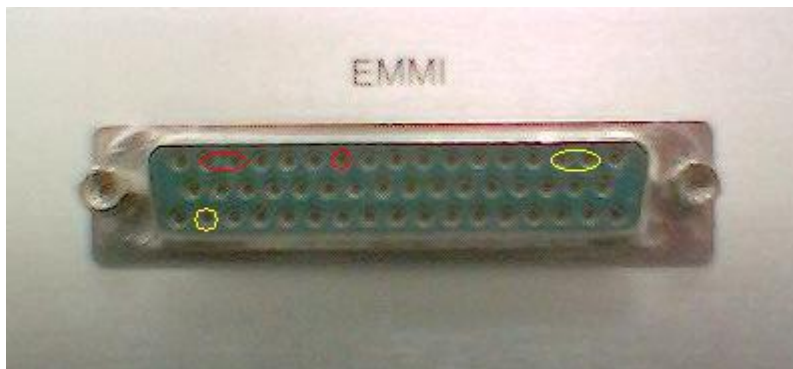
Check Pins 11 and 15/16 are short.

Check Pins 49 and 2/3 are short.

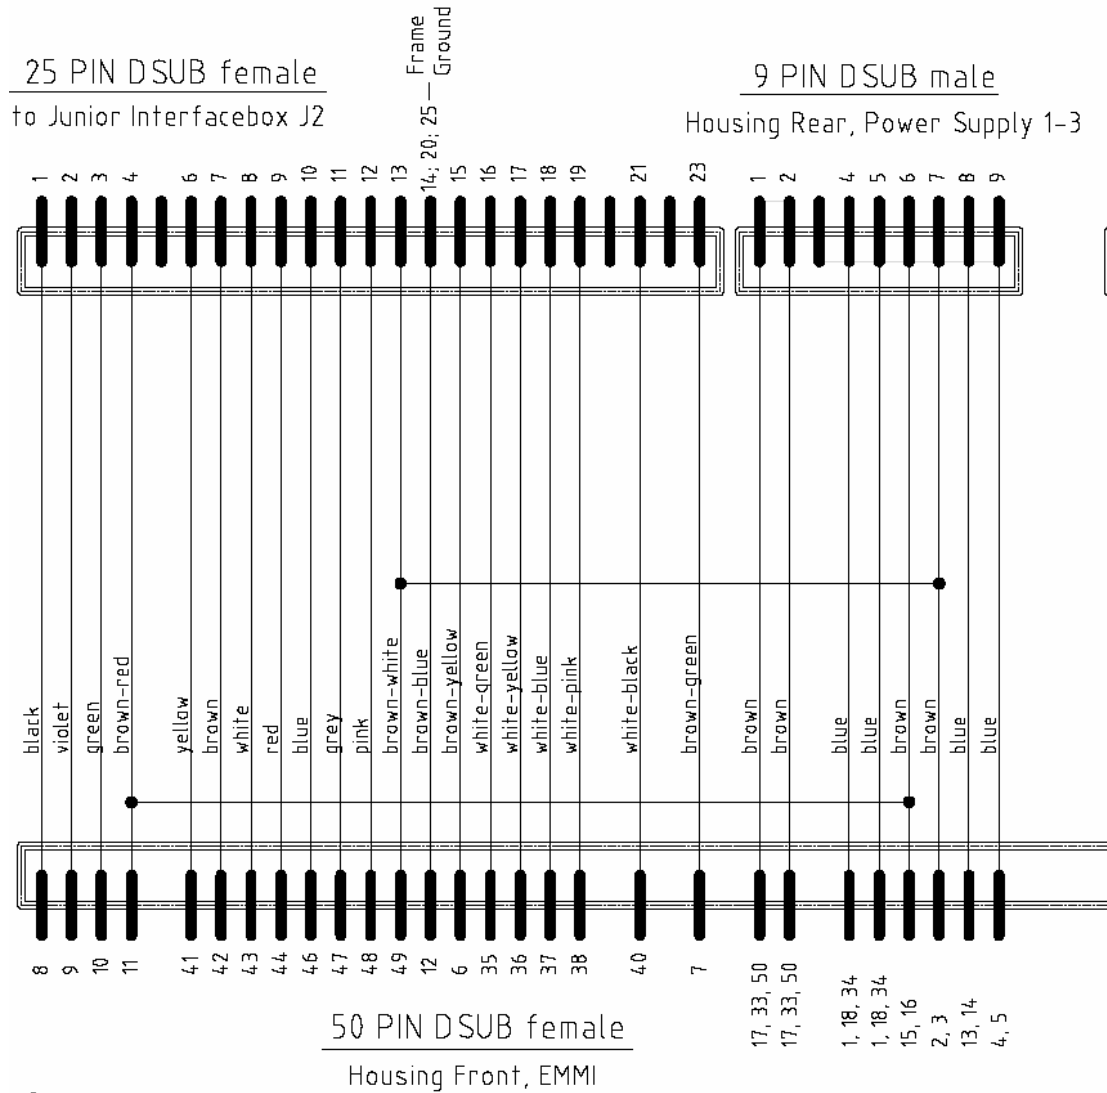
Fig 1.

If these are found to be open circuit then carry out the following modification:

Open the EMMI / Junior Box Casing and identify the connections detailed in Fig1. Make the shorts between the pins and re-assemble the box. You should now be able to interface to V3 Phones by using GPGate.
