FIELD SERVICE BULLETIN

FSB Number: BJCCFSB2005-342
Author: Zhong YJ;
Date: 21th .Nov. 2005
Total No. Of Pages: 3
Subject: V3C RUIM-Heathrow Keypad Peel Off Issue
Model Affected: V3C RUIM-Heathrow (CDMA RUIM PRC Only)
Level of Repair: Level 2

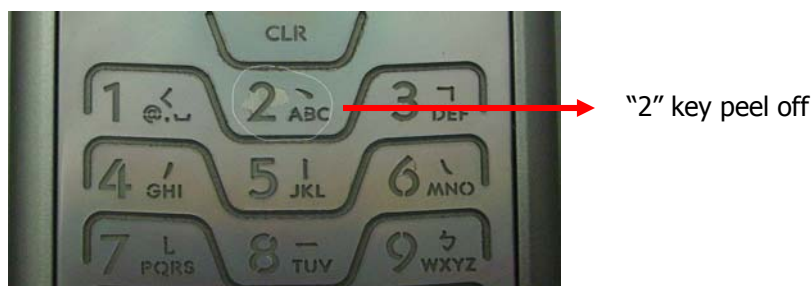
This issue has been identified during the V3C RUIM NPI returns, the customer complained "Main Keypad, wear", the symptom is "2" key peel off. Root causes are following: the adhesion between top coating and metal substrate is partially not formed appropriately due to the high humidity and low temperature; The original humidifier at top coating line has lack of capacity and it was out of control limit of the humidity; Especially at night time working, humidity is higher than the day time and it can deteriorate the adhesion characteristics. Please see the picture.

1. To tightly control the humidity, new dehumidifier is installed additionally at the top coating line ;
2. Control temp/humidity tightly as 22 -27C and below 60% for process control margin;
3. Cross cut test is added as in-line testing after top coating process (2 pcs sampling every 300 pcs)

1. Please verify this kind of symptom for customer complained phone;
2. Disassembled return phone and replace an improvement keypad part, then reassembled. (please follow assembly process)
3. Re-verified this symptom.
(If the symptoms shown by the returned unit don't match those shown or does not fix the issue, service personnel should continue with normal troubleshooting procedures.)
4. Return repaired phone to customer.

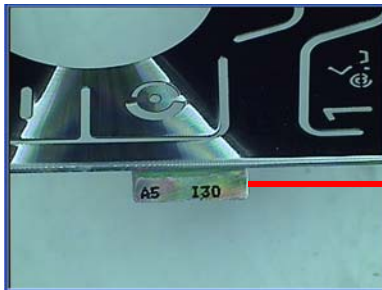
Keypad P/N: 37-82000-01

Improvement part D/C is after Sep.30.05 and marked on the side.

Please see the picture.
