FIELD SERVICE BULLETIN

FSB Number: BJCCFSB2006-143
Author: Feng Joanna
Date: Apr 6, 2006
Total No. of Pages: 3
Subject: **V3i Earpiece Distortion in a Call_Diaphragm not Adhered Firmly**
Model Affected: V3i
Level of Repair: 2

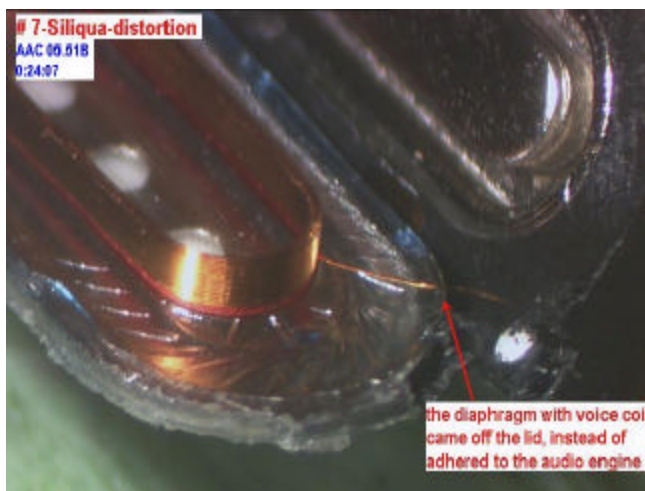
This issue is due to the earpiece diaphragm not adhered to the bottom housing seating plane firmly. The excessive gel was the root cause for the loss of diaphragm adhesion. Due to the gule is too much on the diaphragm during manufacturing, the glue stuck on the housing and accumulated little by little because of diaphragm vibration after several cycle tests or the mobile phone worked for a long time, which made the low sound and distorted sound.

Figure 1: The diaphragm/voice coil sub-assembly had come off with the metal lid as the adhesive lid was peeled off for internal visual inspection. A diaphragm not adhered to its seating plane on the bottom housing allowed the diaphragm to flap and cause the distortion.

AAC has adjusted the glue pressure from 0.04--0.08mpa to 0.04--0.06mpa to control glue amount, so that they can prevent the glue too much when the glue pressure was close to the upper limit and the scope of glue pressure was too big.

When servicing any V3i customer return with described issue, check the part date code at first. If it is "05.51" or older, replace the Pfl ex. The part No. is 8489906Y01. Otherwise, please follow normal troubleshooting procedure on this unit or send it to Motorola for further analysis.

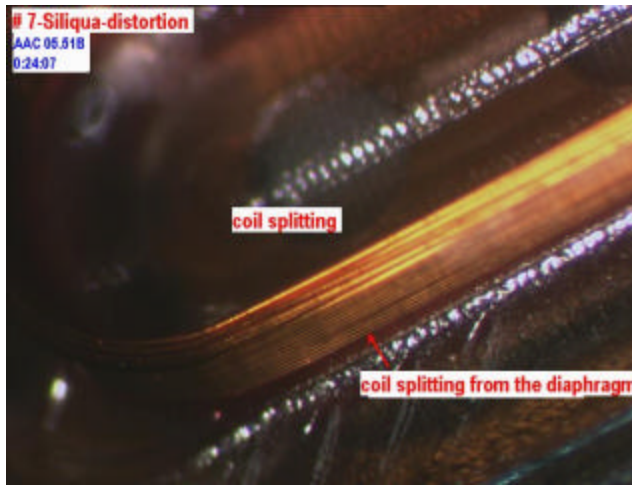
Figure 2: The splitting wire windings due to inadequate bonding is believed to precede the voice coil over-heating and scrambling.
