FIELD SERVICE BULLETIN

FSB Number: BJCCFSB2006-198
Author: Feng Joanna
Date: May 11, 2006
Total No. of Pages: 2
Subject: **V3i Kflex 50 Pin Connector Corrosion**
Model Affected: Siliqua V3i
Level of Repair: 2

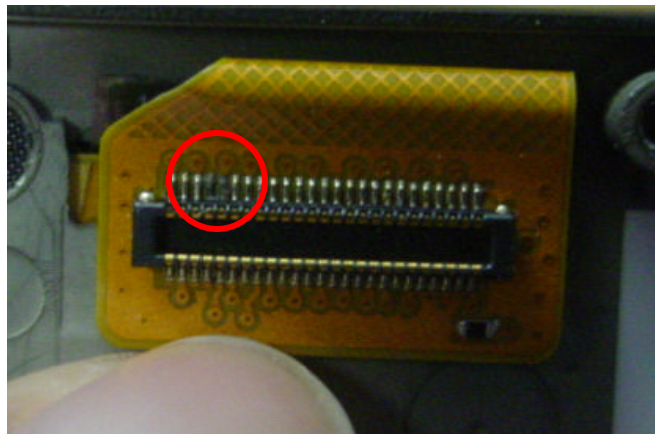
Service has been aware of an issue of V3i Kflex 50 pin connector corrosion results in a complaint of "Turn on/off, Auto power down in standby", which is identified in V3i PRC MOL analysis. The symptom is phone auto power down when pressing keys after power up. Pin 7 (PWR_SW) and pin 9 (LEDB1) on the Kflex 50 pin connector were found corroded. See Figure 1.

Figure 1: Pin 7 (PWR_SW) and pin 9 (LEDB1) on the Kflex 50 pin connector were found corroded.

The failure's supplier is Mflex. They confirmed it is flux residue on the connector pin, if it was exposed in air for long time, it would be black. The failure should be caused by not cleaning clearly after rework.

Flux residue should be cleaned completely after rework according to WI. This failure has been presented to rework supervisor and the picture was showed to all operators for alert. Rework QC strictly controlled the inspection for this failure from Apr 10 on (DC: 1506).

When servicing any V3i customer return with described issue, check the Kflex supplier and its Date Code. If it is Mflex's and DC before 1506, replace the Kflex. The part No. is 8471183B01. Otherwise, please follow normal troubleshooting procedure on this unit or send it to Motorola for further analysis.

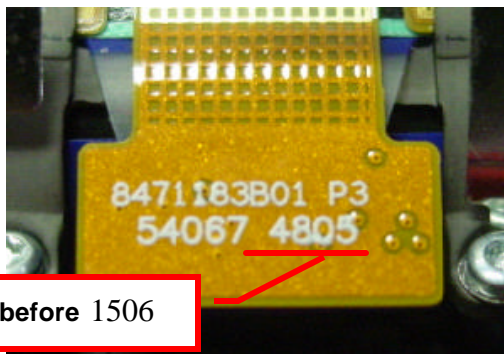
Figure 2: Mflex 8471183B01

Date Code before 1506
