FIELD SERVICE BULLETIN

FSB Number: **Preliminary** BJCCFSB2006-346
Author: Feng Joanna
Date: July 24, 2006
Total No. of Pages: 3
Subject: **V3i Keypad Heating_Wrong Capacitor Placed in EL Circuit**
Model Affected: GSM V3i
Level of Repair: 2

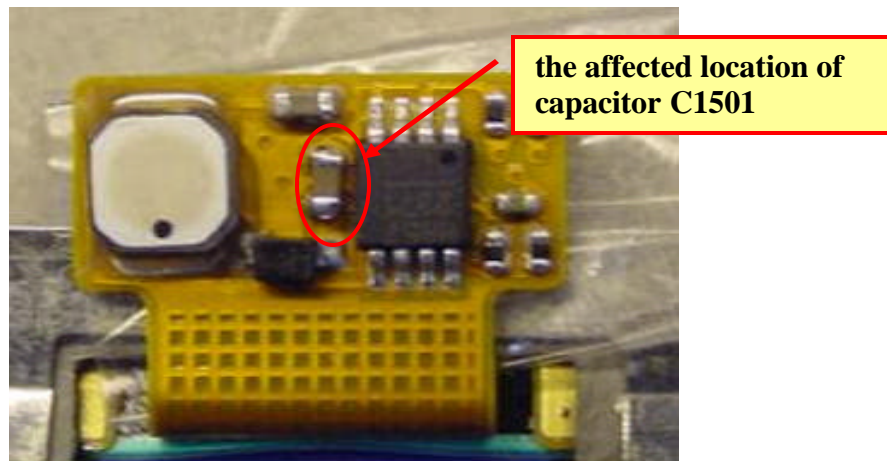
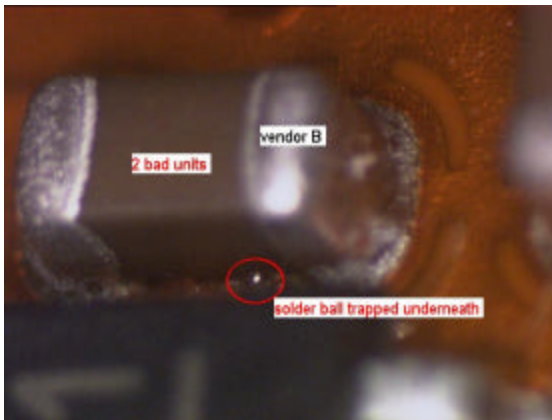
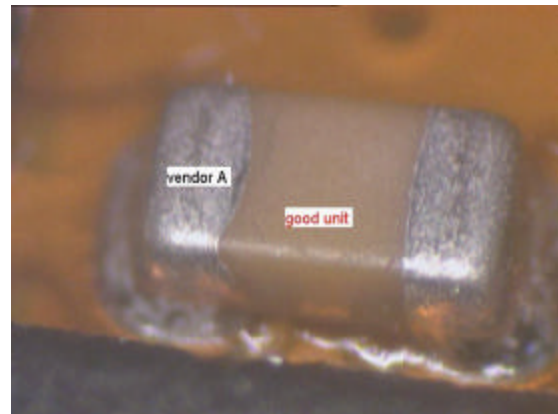
Service is aware of an issue, which has been identified in the analysis of V3i MOL returns. The symptom is high current drain at power supply and noticeable heat on the main keypad. It may finally cause the customer complaint of "Main Keypad, No/dim Backlight". The bypass capacitor C1501 in the EL circuit was found shorted.

The root cause is that a wrong valued capacitor was misplaced on the location of the capacitor C1501 (3300-pF) in the EL circuit. The failed Kflex is assembled by one of V3i Kflex suppliers, FAT (Foxconn Advanced Technology Inc). The affected Date Code is 1506 (= Week 15, Year 2006). Another supplier M-Flex is not affected.

Figure 1: The wrong valued capacitor on the left looks very different from the truly 3300-pF capacitor on the right. The wrong valued part has a dark brown body that is thicker but narrower as compared with the 3300-pF capacitor having a light brown body.

2. Verify the current drain at power supply after phone display shows "Insert SIM";
3. If the current drain is larger than 0.2A, replace the Kflex (part No. 8471183B02).

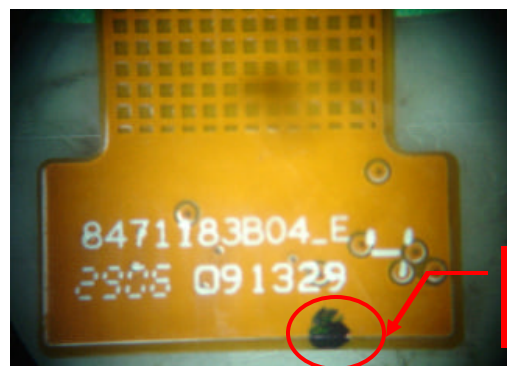
Figure 2: FAT's Kflex after containment action

100% sorted k-flexes are identified by adding blue dots

1. FAT started 100% manual inspection after C1501 and C1502 SMT processes to verify the corrective capacitors being mounting. Starting date: 7/11/06
2. MSE started 100% manual inspection by flip assembling line before k-flex is assembled. Starting date: 7/17/06 (Week 29, Year 2006)
3. 100% sorted k-flexes are identified by adding blue dots near the silk print. Starting date: 7/11/06

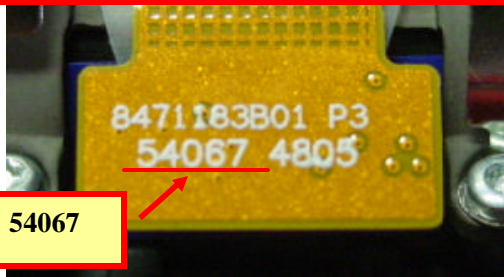
M-Flex: 54067

Part Identification: Currently there are two suppliers for the V3i Keypad flex: M-Flex and FAT, which have different ID numbers on the back of the Kflex.

Date Code Shown: 0206 = Week 2, Year 2006

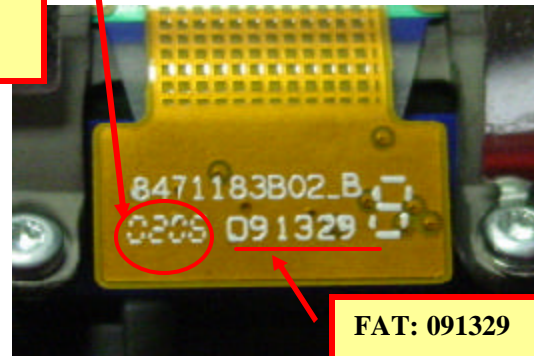
FAT: 091329

Affected Date Codes: 1506

Please purge existing inventory of FAT's Kflex with Date Code 1506. **P/N(s):** 8471183B02
