FIELD SERVICE BULLETIN

FSB Number: BJCCFSB2006-347
Author: Feng Joanna
Date: July 24, 2006
Total No. of Pages: 2
Subject: **V3i Keypad Poor Tactile_Contamination on golden pad**
Model Affected: GSM V3i
Level of Repair: 2

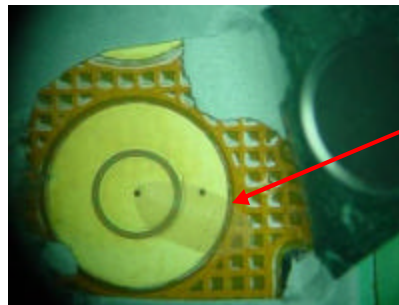
It is due to a contamination coming from the glue coating process. Improper pressure was given to nozzle and caused glue overflow, which contaminated the golden pad and solidified on flex surface after oven. The affected Kflex supplier is M-Flex.

Golden pad contamination

1. A special line leader has been assigned to verify the intensity of pressure and ensure it is between 10 to 50 PSI, at each operator's start up of each shift. If the pressure of the nozzle is found to be out of spec, the glue tube will be scrapped and a new tube will be used – 06/21/06.

2. Additional inspection to the flex surface after glue coating was added prior to the UV curing step – 06/22/06.
3. IPQC will enhance the inspection to this glue coating fixture control and the golden pad contamination and while doing first article checking and sampling checking at conformal coating station – 06/22/06.
4. Require the PSA lay-up line to clean the entire flex surface using a no-dust cloth and alcohol to wipe off the flex surface before pasting EL panel and ensure the cleanness of the surface prior to pasting the el Panel. This will also aide in feeling any raised surface on the dome pads. Operator's are also required to perform a 100% check of the surface after cleaning – 06/22/06 (Week 25, Year 2006).

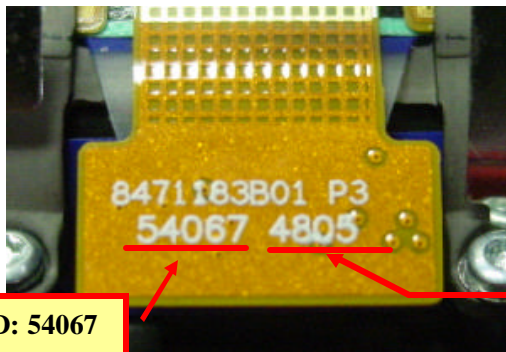
M-Flex ID: 54067

Date Code: 4805 = Week 48, Year 2005
CA Date Code: 2506 = Week 25, Year 2006

When servicing any V3i customer return with described issue, check the Kflex Date Code firstly. If it is Mflex's and Date Code before 2506 (= Week 25, Year 2006), replace the Kflex. The part No. is 8471183B02. Otherwise, please follow normal troubleshooting procedure on this unit or send it to Motorola for further analysis.
