FIELD SERVICE BULLETIN

FSB Number: BJCCFSB2006-75
Author: Feng Joanna
Date: Mar 16, 2006
Total No. of Pages: 4
Subject: **V3i Earpiece No_Solder Crack on the Earpiece Pad (Rev A)**
Model Affected: V3i
Level of Repair: 2

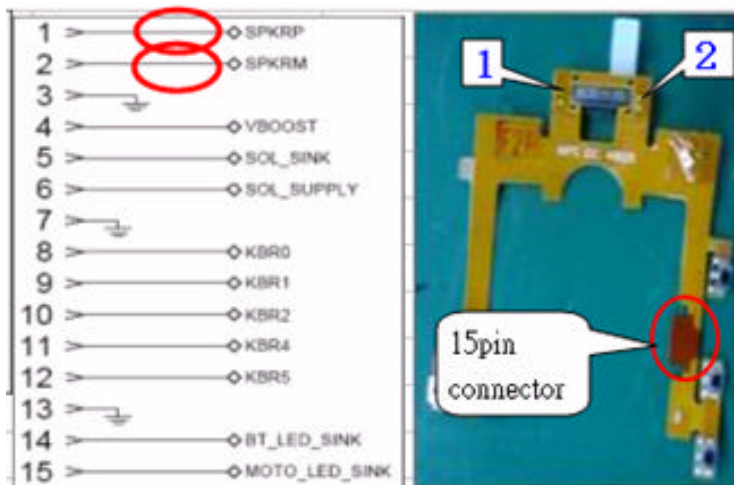
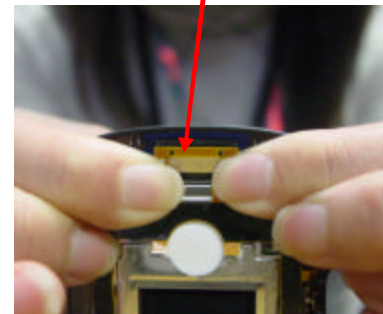
Service has been aware of a customer complaint of "Audio, Earpiece no". The earpiece is good (around 30 ohm). The resistance between SPKR_P and SPKR_M on Pflex 15 pin connector is infinite, and the earpiece performance might recover when pressing the solder pad by force.

The earpiece performance can recover when pressing the solder pad.

The issue is due to Pflex trace crack at the earpiece solder pad.

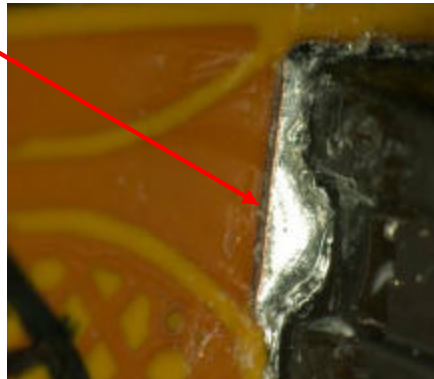
Failure Mode has been confirmed to be speaker pad cracked completely.

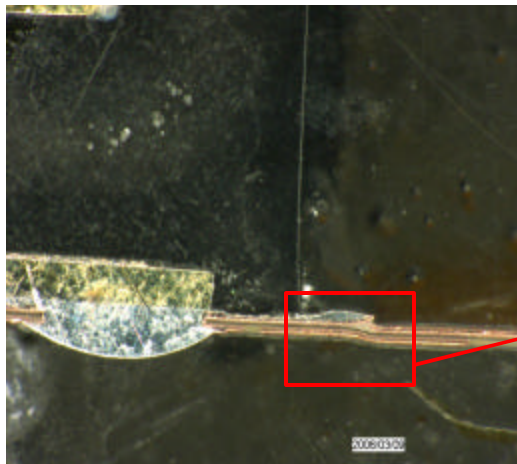
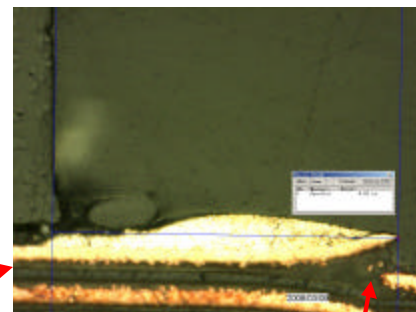
The Cross-Section confirmed that the speaker pad has been disconnected at copper level. See the pictures shown below.

Crack trace at solder joint

Root Cause has been establish as flip assembly induced damage resulting in immediate and latent micro crack of traces leading into the speaker pad-stack.

- 1) Foxconn and JinYa have been stopped any re-work during flip assembly process.
- 2) To add UV Curable Epoxy to the earpiece pad area has been approved immediate implementation in the P flex supplier as picture shown below.

The proposed cover coat design change will be applied to make the P Flex more robust to survive from the assembly work.

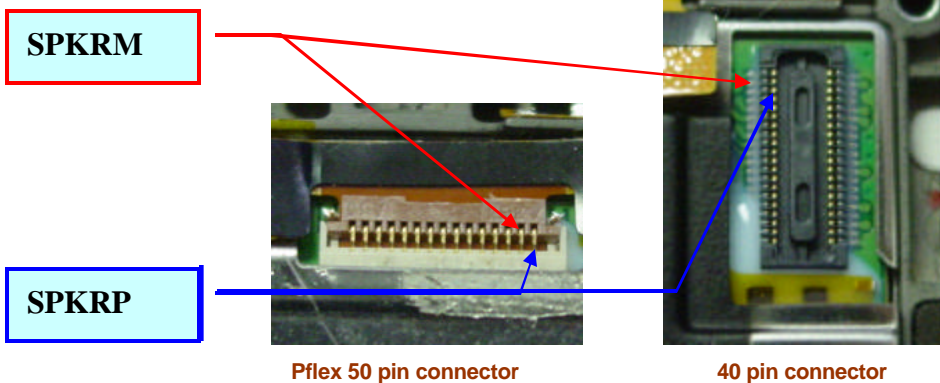
- 1) Check if the resistance of the earpiece is normal (around 30 ohm);
- 2) Check if the resistance between SPKR_P and SPKR_M is infinite on the Pflex 15 pin connector or on the 40 pin connector.

If both checks are confirmed ok, and the earpiece pad area has no epoxy bead, replace the P flex (part No. 8489906Y01). Otherwise, please follow normal troubleshooting procedure on this unit or send it to Motorola for further analysis.
