## FIELD SERVICE BULLETIN

FSB Number: BJCCFSB2006-76  
Author: Feng Joanna  
Date: Feb 28, 2002  
Total No. of Pages: 2  
Subject: **V3i Earpiece Noise\_Pflex Bezel Shorting**  
Model Affected: V3i  
Level of Repair: 2

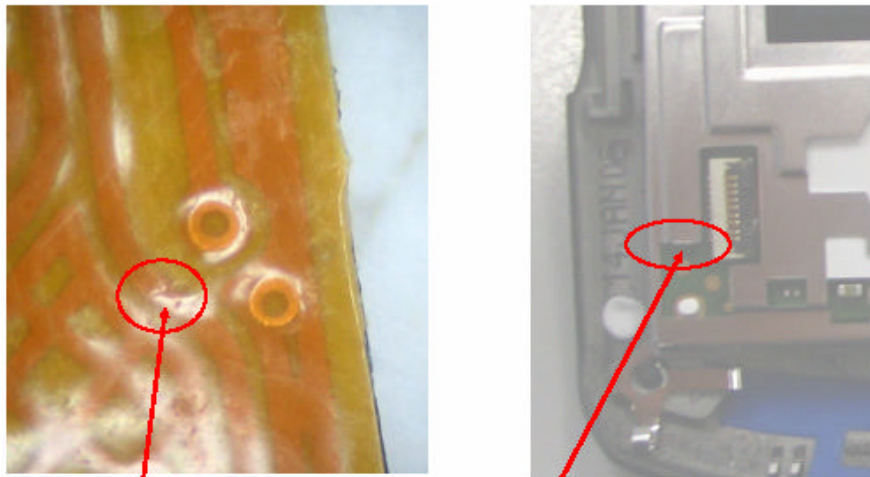
Service has been made aware of a complaint with “Audio, Earpiece noise/ distortion when making a call or pressing keys”. The root cause is the SPKR\_P line on the Pflex shorted at the metal bezel edge due to a forcing abrasion. The symptom is SPKR\_P pin short to GND (normally should be open) on the Kflex 50 pin connector before disassembly the flip. The earpiece performance quality will recover after disassembly the flip.

A nick was found at the SPKR\_P line on the edge of the bezel, which caused SPKR\_P short to GND.

The defect could be prevented because Foxconn should add an new Kapton tape on the bezel edge from Feb 13, 2006.

When servicing any V3i customer return with described issue, check the bar code label on the front housing assembly. If it is before 02/13/06, replace the Pflex and add a Kapton tape on the bezel edge. The part No. is 8489906Y01. Otherwise, please follow normal troubleshooting procedure on this unit or send it to Motorola for further analysis.
