FIELD SERVICE BULLETIN

FSB Number:	BJCCFSB2006-109
Author:	Feng Joanna
Date:	Mar 16, 2006
Total No. of Pages:	3
Subject:	V3i Can't Enter Camera Mode_Connector Pin Deformed
Model Affected:	V3i
Level of Repair:	2

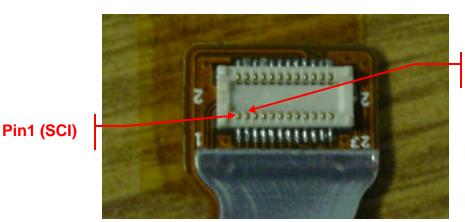
Pin3 (SDA)

This issue is due to the poor connection between the camera and the ATI. Pin 1(SCI) and Pin 3 (SDA) was found deformed on the camera flex 24 pin connector, which are to communicate with ATI circuit.

When servicing any V3i customer return with described issue, replace the camera module (Part No. 8489891Y01). Otherwise, please follow normal troubleshooting procedure on this unit or send it to Motorola for further analysis.
