MOTOROLA UK
REDWOOD
CROCKFORD LANE
CHINEHAM BUSINESS
CHINEHAM
BASINGSTOKE
UNITED KINGDOM R

CSB-1224-2
Country : UK
Date : 2/18/2007
APC : ALL
Repair Level : 2

RAZR V3i - GSM - Static Audio – P-Flex shorted to display bezel
V3i & V3t

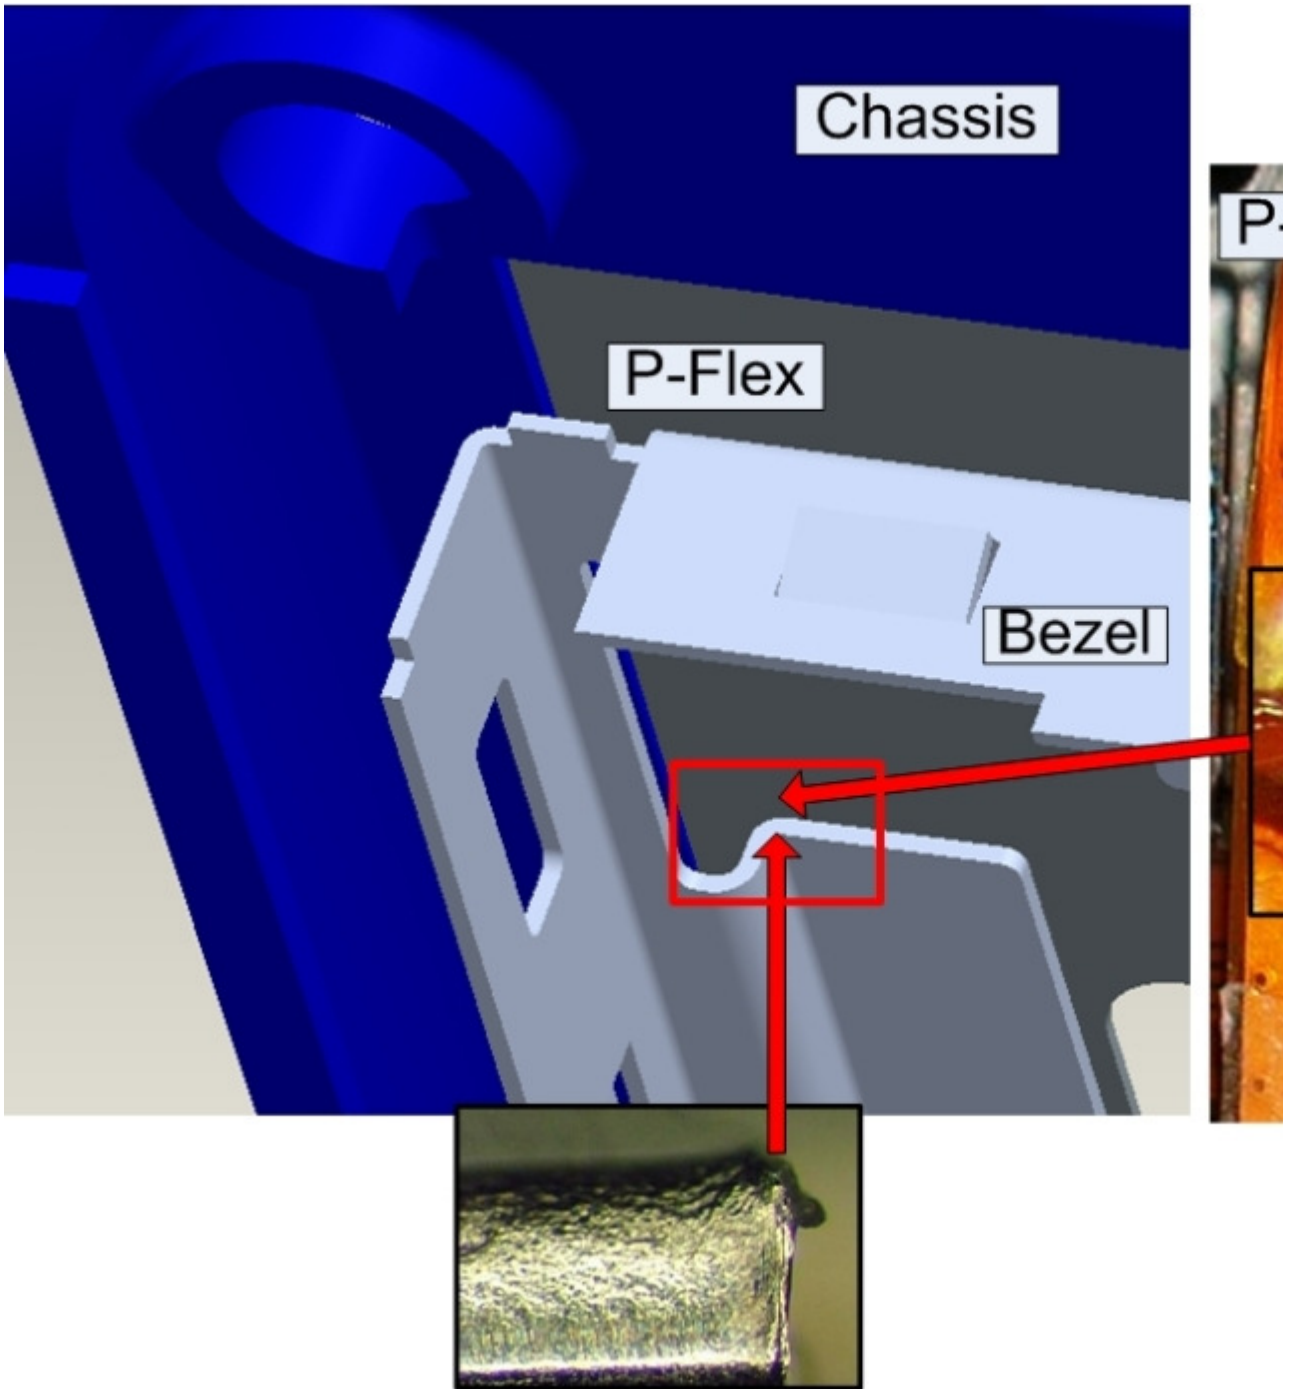
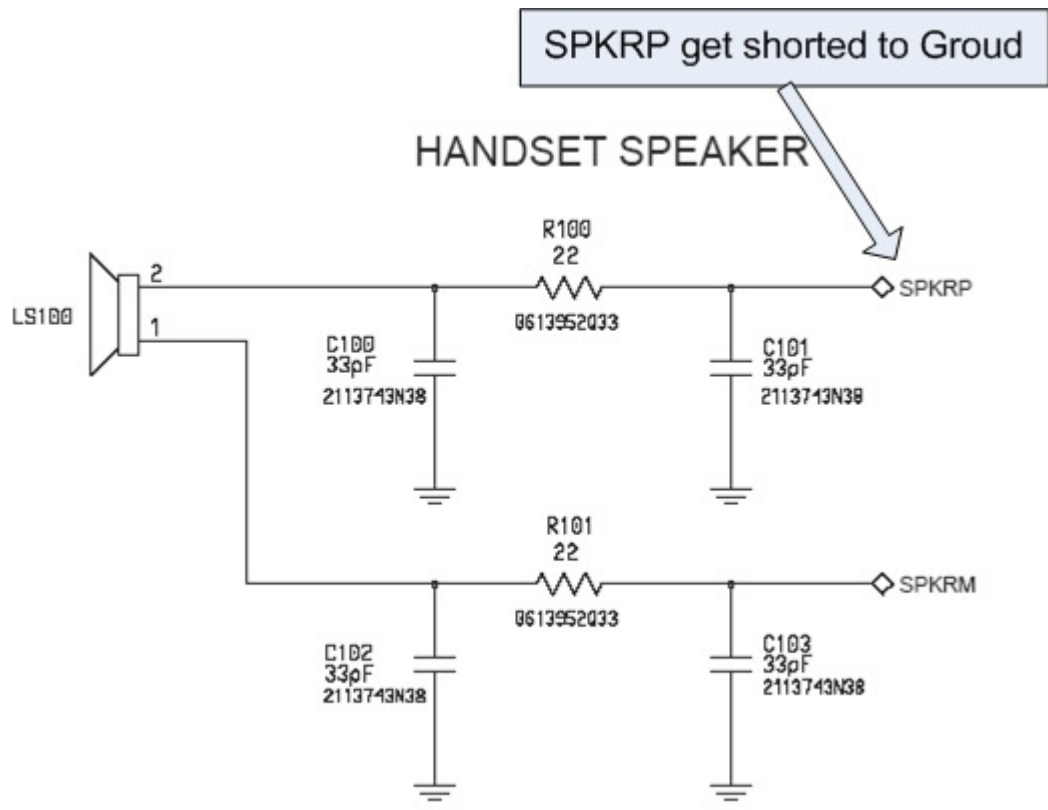
Service has been made aware of a V3i/V3t Siliqua P-Flex Shorting issue in where only static audio can be heard from the ear during power on, key press, and in a call. The P-Flex contains SPKRP audio traces for the earpiece speaker. This flex is being shorted and grounded by a burr on the display bezel. Also refer to BJCCFSB2006-76.

There are two main contributing factors, the placement of the kapton tape and the burr on the display bezel. First the kapton intended to protect the P-Flex from the display bezel edge which has burr was not being placed correctly during the assembly thus allowing the bezel burr to come into contact with the flex. Second the burr created during the stamping of the display bezel was found to be sharper than expected, which allows the burr to become more dangerous to the P-Flex.

Manufacturing has corrected the placement process of the kapton tape on 2/9/2007. The display supplier is improving the manufacturing process to reduce burrs of the bezel.

When servicing any V3i/V3t customer phones with described issue, the P-Flex must be replaced and kapton tape added. Pe Flex Assy # 8489906Y01 Kapton Tape # 1171760D01. All repairs in where the P-Flex is replaced, the kapton tape must be placed on the display bezel with the bend corner and burrs completely covered (See Placement Instructions).

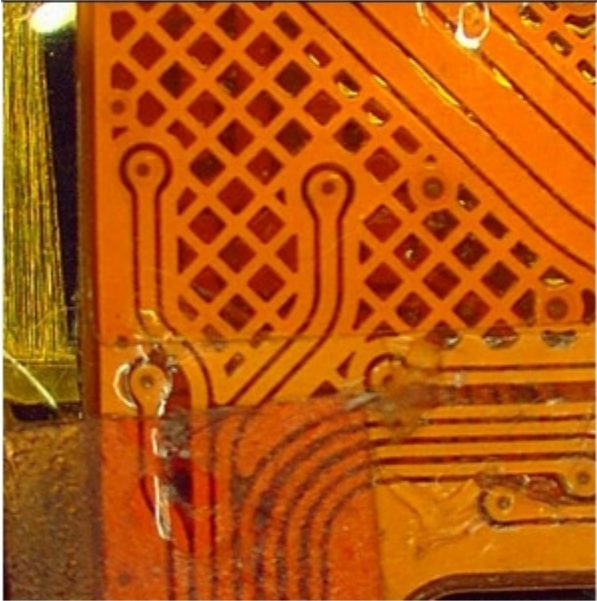
Incorrect -
Placement of tape
on the P-Flex

APPLY KAPTON TAPE TO THESE 3 EDGES OF THE DISPLAY BEZEL.
