CSB-1105-3
 Country : UK
 Date : 11/1/2006
 APC : ALL
 Repair Level : 3

Title RAZR V3i - GSM - GSM V3i - Alert - No Ringtone
 Model Effected All
PROBLEM

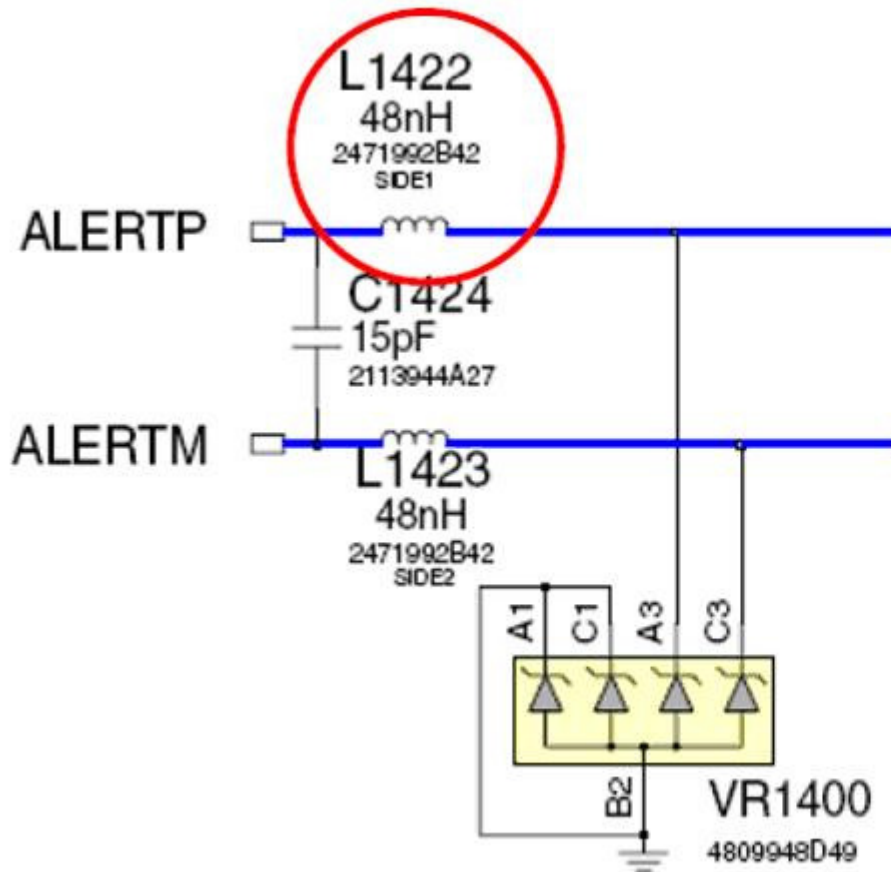
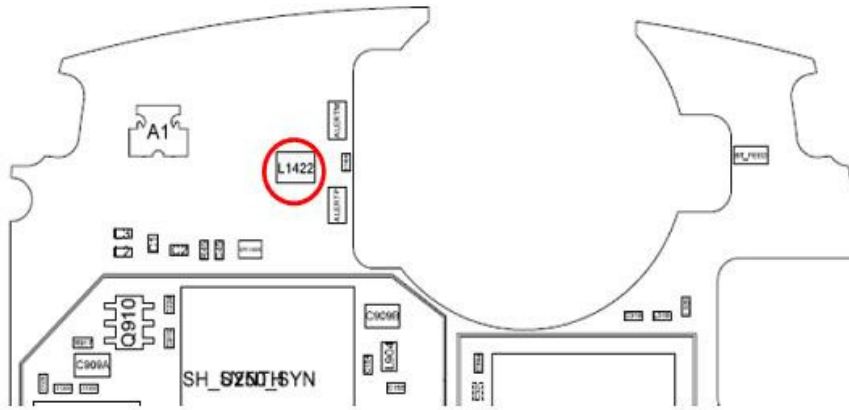
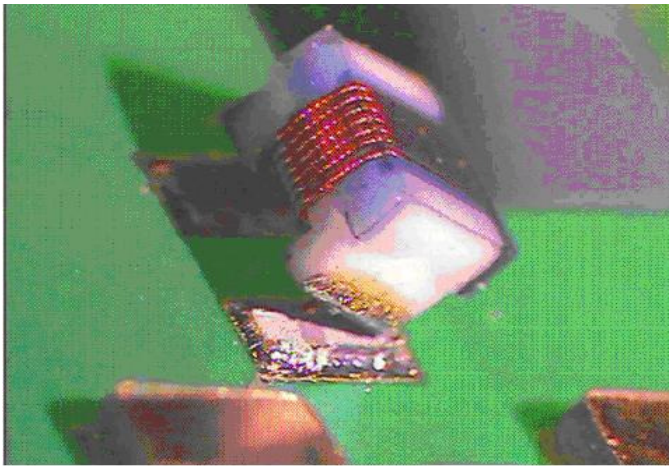
Service is aware that some GSM V3i phones from Brasil have been returned with customer complaints related to Alert – No Ring. The failure mode analysis revealed that the inductor L1422, Part Number 2471992B42 is being damaged in the manufacturing assembly process, thus causing customer to notice a difficult with ringtones - no alert audio. See pictures below :

Field solution is to replace the L1422 inductor damaged, missing or misplaced.

1. Verify customer complaint per normal procedure.
2. If customer complaint is confirmed, verify if the inductor L1422, Part Number 2471992B42 is misplaced, broken or missing, according to pictures above.
3. If L1422 is misplaced, broken or missing, proceed the replacement of L1422 as per service procedures.
