FIELD SERVICE BULLETIN

FSB Number: LVCCFSB2005-371
Authors: Darwin Garcia
Date: December 28, 2005

Subject: V3i Bezel Shorting

Model Affected: **V3i** Level of Repair: 2

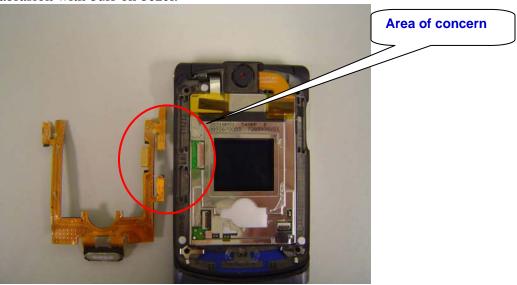
Service has been made aware of a V3i Siliqua Bezel Shorting issue were the M logo and Bluetooth LED will always turn on which could cause "Alert - LED, wrong indicator" complaints. The symptom will show when the SIM cards and the battery are in placed, even without turning on the phone.

The root cause was determined to be P-Flex within flip shorted with metal bezel due to abrasion with burr on bezel.

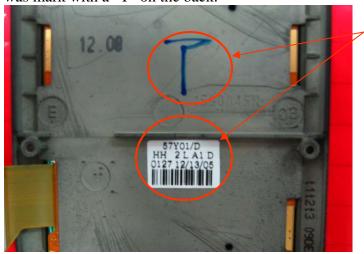
Flips with new 2 tapes on the external bezel

For screened inventory the bar code changed from Y01/C to Y01/D and the front housing was mark with a "T" on the back.

The vendor will add a new step to remove any "burr" from the bezel as permanent corrective action.

When servicing any V3i customer phones with described issue, the P-Flex must be replaced and kapton tape added. Personality Flex Assy # 8489906Y01
