FIELD SERVICE BULLETIN

FSB Number: LVCCFSB2006-100
Authors: Darwin Garcia
Date: March 16, 2006
Total No. of Pages: 3
Subject: **V3i Torn K-Flex**
Model Affected: **V3i**
Level of Repair: 2

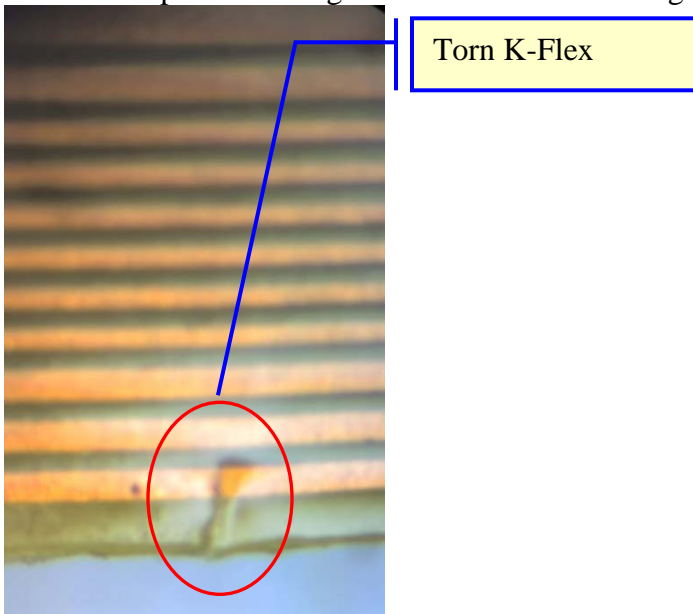
Service has been made aware of a V3i Torn K-Flex issue causing “Display Main - No display” complaints.

Initial analysis found that the tear at the “snake” area occurred during assembly when the K-Flex was pushed through the chrome knuckle hinge.
