FIELD SERVICE BULLETIN

FSB Number: LVCCFSB2006-14
 Authors: Darwin Garcia
 Date: February 22, 2006
 Total No. of Pages: 3
 Subject: **V3 & V3i Keypad Backlight Low Brightness**
 Model Affected: **V3, V3i**
 Level of Repair: 2

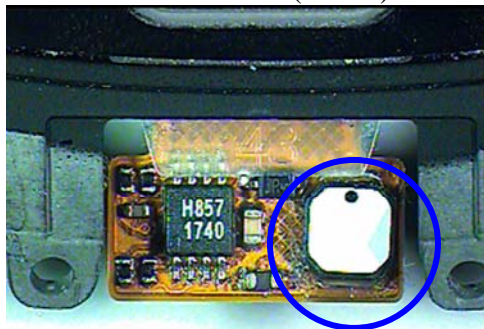
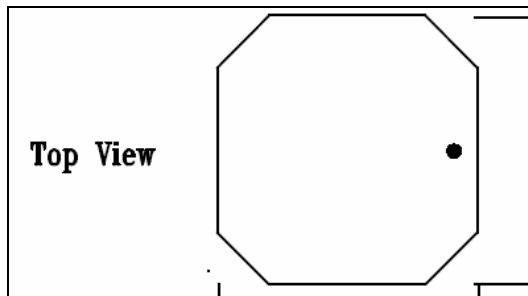
Coilcraft EL Inductor (White)

The root cause of the dimmer EL panel was the shorting of the core of the Coilcraft EL inductor to the soldered contacts causing a higher current drain.
 EL Inductor suppliers for V3 and V3i

Coilcraft converted the EL inductor to a paralyne coating to prevent the shorting on November 9th as a running change.

When servicing any V3 and V3i customer phones with described issue, the K-Flex must be replaced. For V3 = 8489976N03 and for V3i = 8471183B02

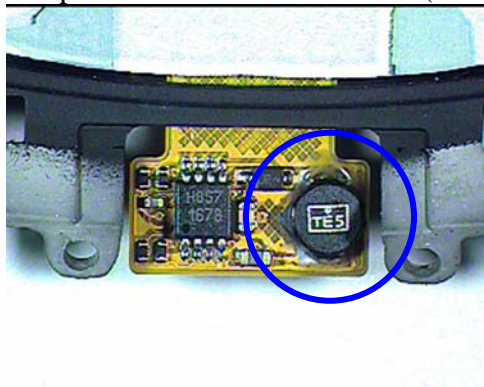
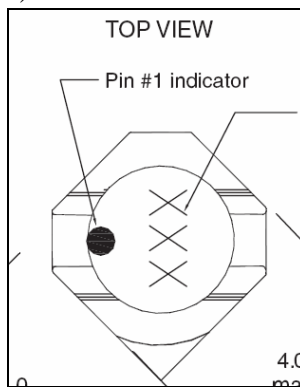
Cooper Coiltronics EL Inductor (Black)

Note: Cooper Coiltronics EL Inductors were NOT impacted by this issue.
