FIELD SERVICE BULLETIN

FSB Number: LVCCFSB2006-319
Authors: Tony Bryan
Date: July 27, 2006
Total No. of Pages: 4
Subject: RFMD_SYNTH IC – Open Circuit (cracked via)
Model Affected: V3i, V3-05, U6, L7, A1200, E2
Level of Repair: 3

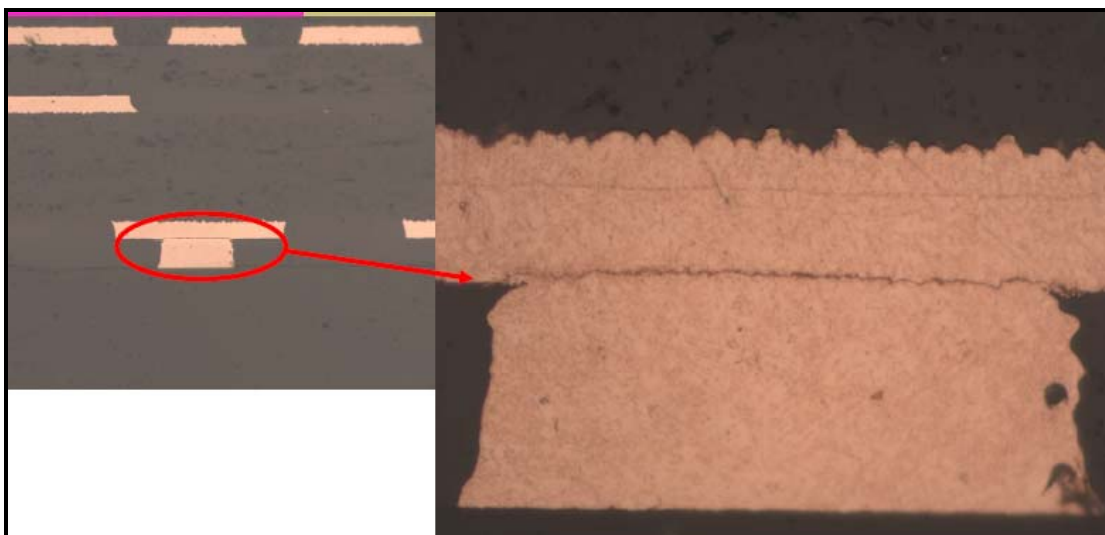
Service is aware of an issue, identified in the NPI Analysis of several GSM products using the RFMD_SYNTH IC (P/N(s): 5188450M38 and 5188169Y01). Some units, returned with customer complaints of “Voice Call-No Service”, “Voice Call – Can’t Make/Receive Calls”, “No Turn On”, and “Invalid Battery”, were found to be caused by inoperative RFMD_SYNTH IC. The failure identified was an open circuit resulting from via cracks within the substrate of the IC. This failure mode can be intermittent and sensitive to temperature.

The root cause was determined to be a process control issue at the second source substrate supplier, UMTC, that resulted in a via that is more susceptible to cracking. RFMD was utilizing two suppliers to produce the IC substrate. Supplier UMTC was introduced into production in February 2006. RFMD_SYNTH IC’s built with substrates produced from first source supplier, Subtron, are not affected by this issue.

Fig. 1.0 – Cracked Via from failed component

Factory and Supplier Inventories have been 100% screened for affected parts with substrates produced by UMTC. 6/30/2006

Supplier RFMD has stopped all production of substrates by UMTC and is currently shipping only parts built with substrates produced by Subtron as of 7/12/2006.

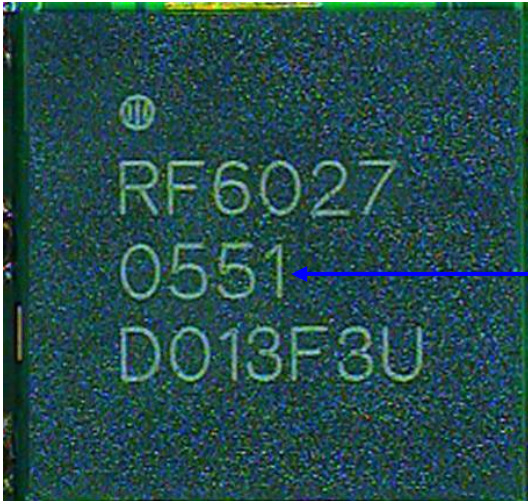
Date Code Shown: 0551 = Week 51, Year 2005

Affected Date Codes: 0603 thru 0626

CA Date Code: 0627 = Week 18, Year 2006

Please purge existing inventory of the RFMD-SYNTH IC with date codes 0603 thru 0626. Re-stock only RFMD_SYNTH IC's with date codes after 0626. See information above for part identification.
