FIELD SERVICE BULLETIN

FSB Number: LVCCFSB2006-33
Authors: Darwin Garcia
Date: February 14, 2006
Total No. of Pages: 2
Subject: **V3i CLI Low Contrast**
Model Affected: **V3i**
Level of Repair: 2

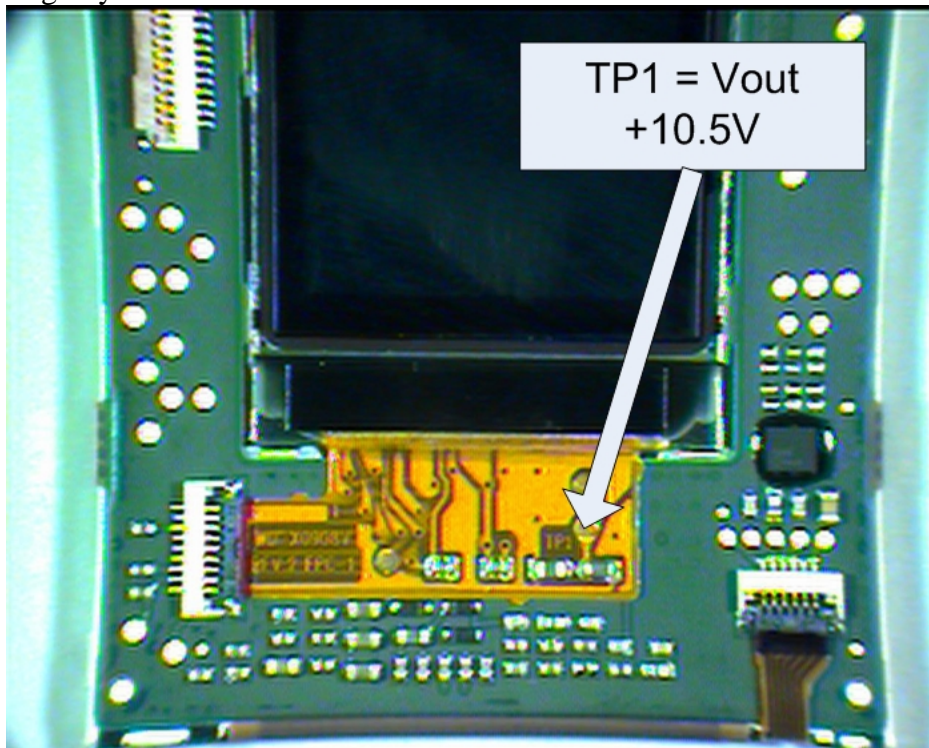
Service has been made aware of a V3i CLI low contrast issue causing “Display Secondary - Low / Dim Backlight” complaints.

Initial analysis determined that the Vout line voltage on the CLI that controls the contrast level was below the desire value of +10.5V, this line is control by the setting on the OTP Registry.
