FIELD SERVICE BULLETIN

FSB Number: LVCCFSB2006-35 (Rev A)
Authors: Darwin Garcia
Date: May 24, 2006
Total No. of Pages: 2
Subject: **V3i Broken/Bent SIM Connector Pin**
Model Affected: **V3i**
Level of Repair: 2

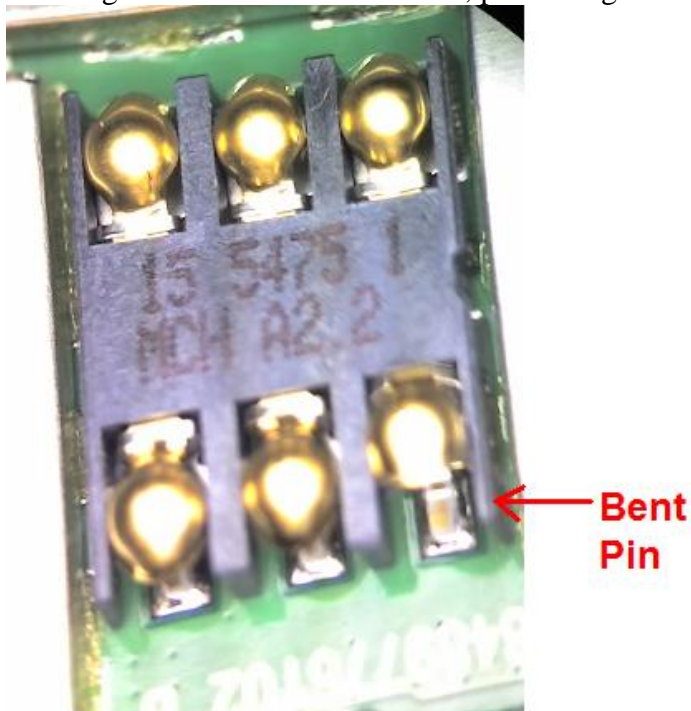
Service has been made aware of a V3i Broken SIM Connector Pin issue causing “Check card / Insert SIM” complaints.

Initial analysis found that SIM connector pin are being broken off or bent off when inserting the SIM card the first time, preventing it from being read.

When servicing any V3i customer phones with described complaint, replace the SIM block connector (Part Number = 3971332A02).

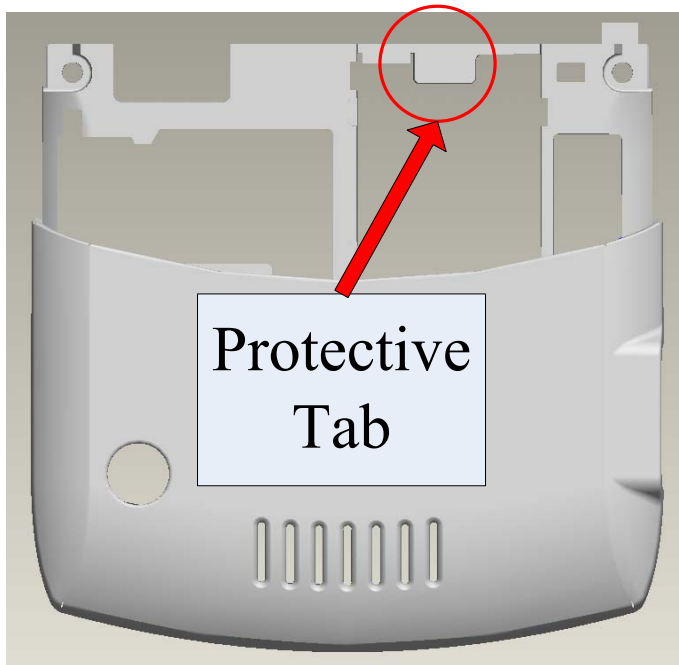
A protective tab has been added to the rear housing to prevent the user from bending or destroying the SIM connector front pins. The tab forces the SIM to run in parallel with the SIM connector’s surface. The new rear housing is being implemented as a running change.

Part Number Revision Change: Rear Housing # 1589798Y01 Rev F.

If the new rear housing is available (PN: 1589798Y01 Rev F) then also replace it.
