FIELD SERVICE BULLETIN

FSB Number: LVCCFSB2006-36
Authors: Darwin Garcia
Date: February 14, 2006
Total No. of Pages: 2
Subject: **V3i Keypad Intermittent – FM Contamination**
Model Affected: **V3i**
Level of Repair: 2

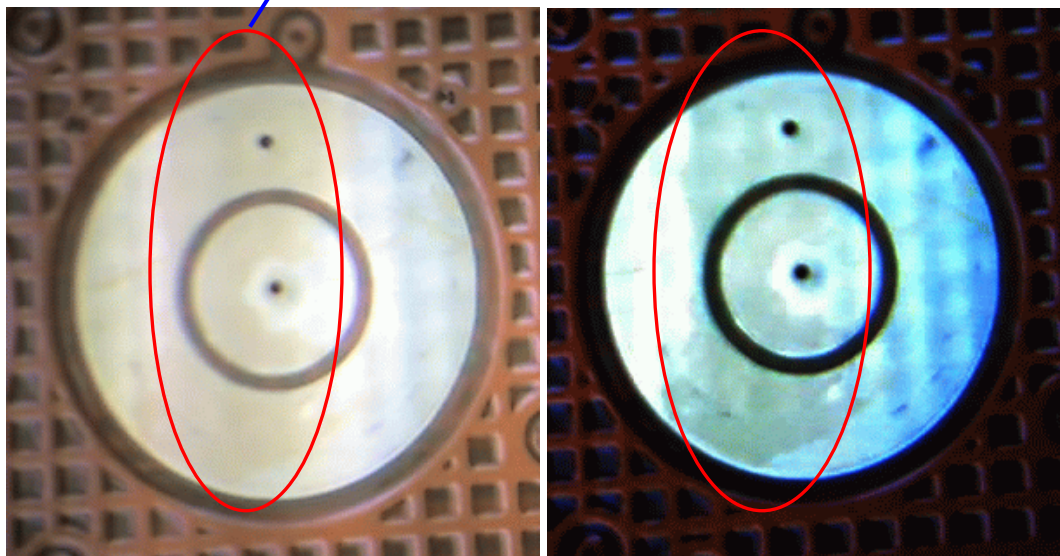
FM Contamination

Service has been made aware of a V3i Keypad Intermittent issue causing “Main Keypad - No function/ hangs” complaints.
Initial analysis found foreign material under the dome on K-flex pads impeding contact.

When servicing any V3i customer phones with described complaint, replace the keyboard flex assembly module (Part Number 22= 8471183B02).
