## **FIELD SERVICE BULLETIN**

FSB Number: LVCCFSB2006-55  
Authors: Darwin Garcia  
Date: February 22, 2006  
Total No. of Pages: 2  
Subject: **V3i Lazy Flip**  
Model Affected: **V3i**  
Level of Repair: 2

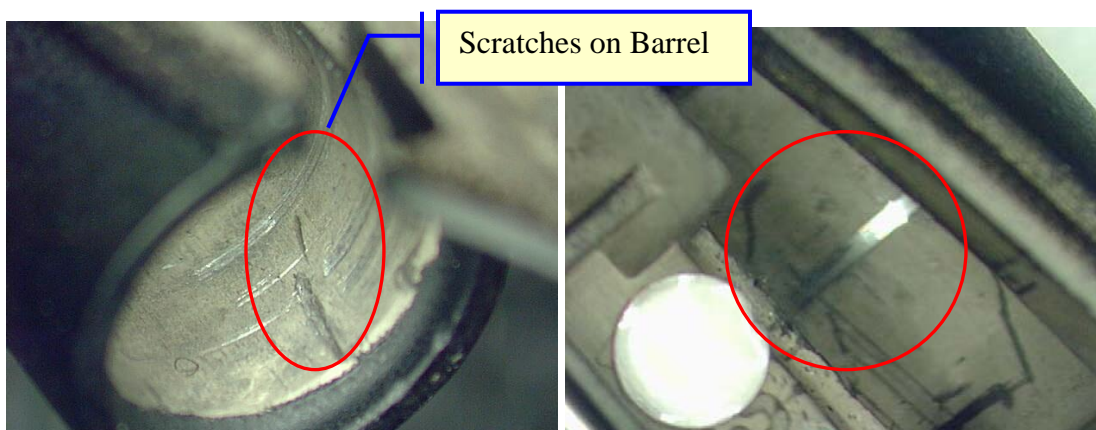
Service has been made aware of a V3i Lazy Flip issue causing “Housing Flip/Blade - Loose” complaints.

Initial analysis found that the stack up of tolerances between the endcap, flip inner, and copper tape causes the endcap to rub against the inside of the barrel.

When servicing any V3i customer phones with described complaint, replace the Hinge Cap Left (Part Number 8= 1589126Y02).
