FIELD SERVICE BULLETIN

FSB Number: LVCCFSB2006-92
Authors: Darwin Garcia
Date: March 16, 2006
Total No. of Pages: 2
Subject: **V3i Tombstone Resistor**
Model Affected: **V3i**
Level of Repair: 2

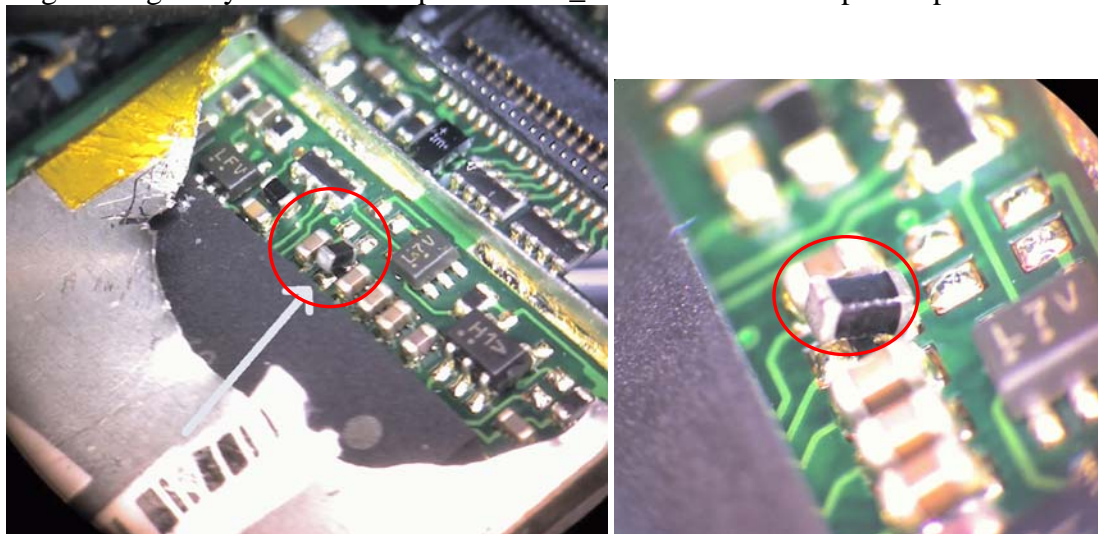
Service has been made aware of a V3i Tombstone Resistor (R805) issue causing “Check card / Insert SIM” complaints.

Engineering analysis found an open on SIM_RST line due to misplaced part R805.

Further analysis determined there was significant difference in pad dimension on the stencil, which led to insufficient solder paste on the part.

The factory fixed this issue by adding more solder paste, which was implemented in January.

When servicing any V3i customer phones with described issue, the R805 resistor must be reflow and align.
