CSB-1004-2
Country : UK
Date : 10/20/2006
APC : D54
Repair Level : 2

Title V3V3 05 CR - GSM - RAZR Earpiece Audio Distortion
Model Effected V3 & V3_05

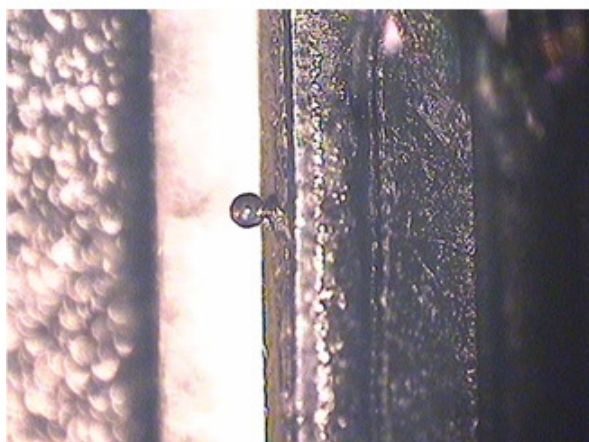
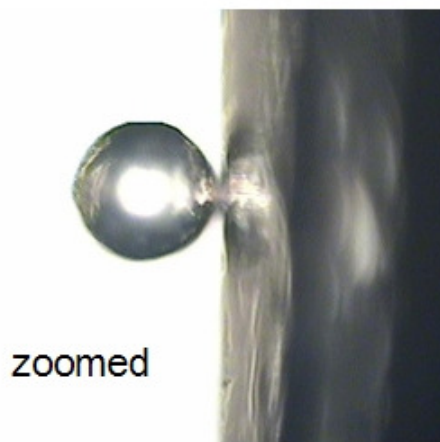
Service has detected an earpiece audio distortion issue during V3 MOL causing "Audio distortion" complaints. The root cause was determine to be FM contamination (solder ball) in the earpiece chamber being introduce during the supplier's manufacturing process (AAC).

The AAC earpiece design was change to add a mesh at the venting holes on the bottom to prevent FM contamination.

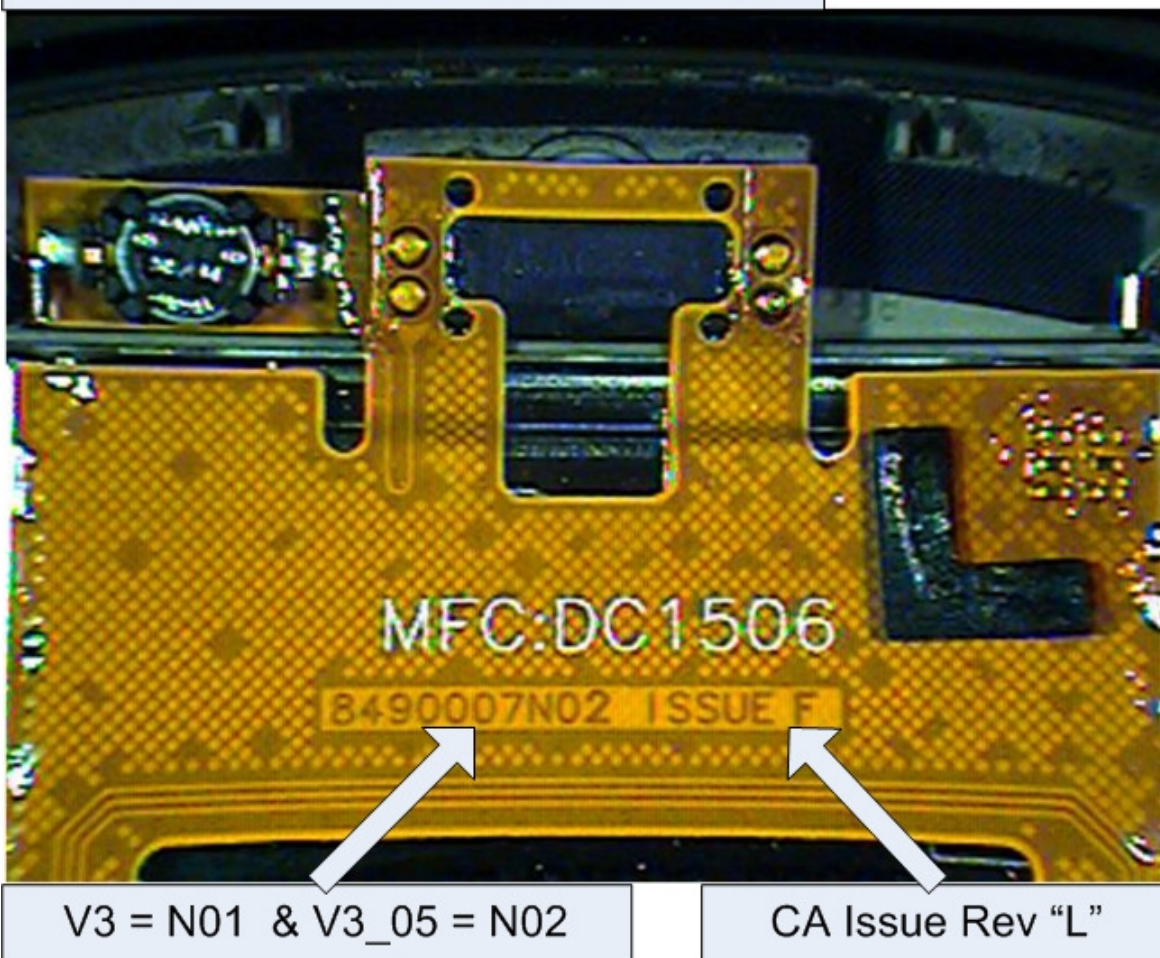
P-Flex Issue Change

The P-Flex revision change to "L".

V3 = N01 & V3_05 = N02

CA Issue Rev "L"

When servicing any RAZR customer phones with described issue, the P-Flex must be replaced. Personality Flex Assy # 8490007N01 (V3) and 8490007N02 (V3_05) .

Service inventory new p-flex orders should be for revision "L" if available.
