# Bulletin

CSB-1011-2  
Country : UK  
Date : 10/5/2006  
APC : D54  
Repair Level : 2

V3V3 05 CR - GSM - RAZR Missing Endcap  
V3 & V3\_05

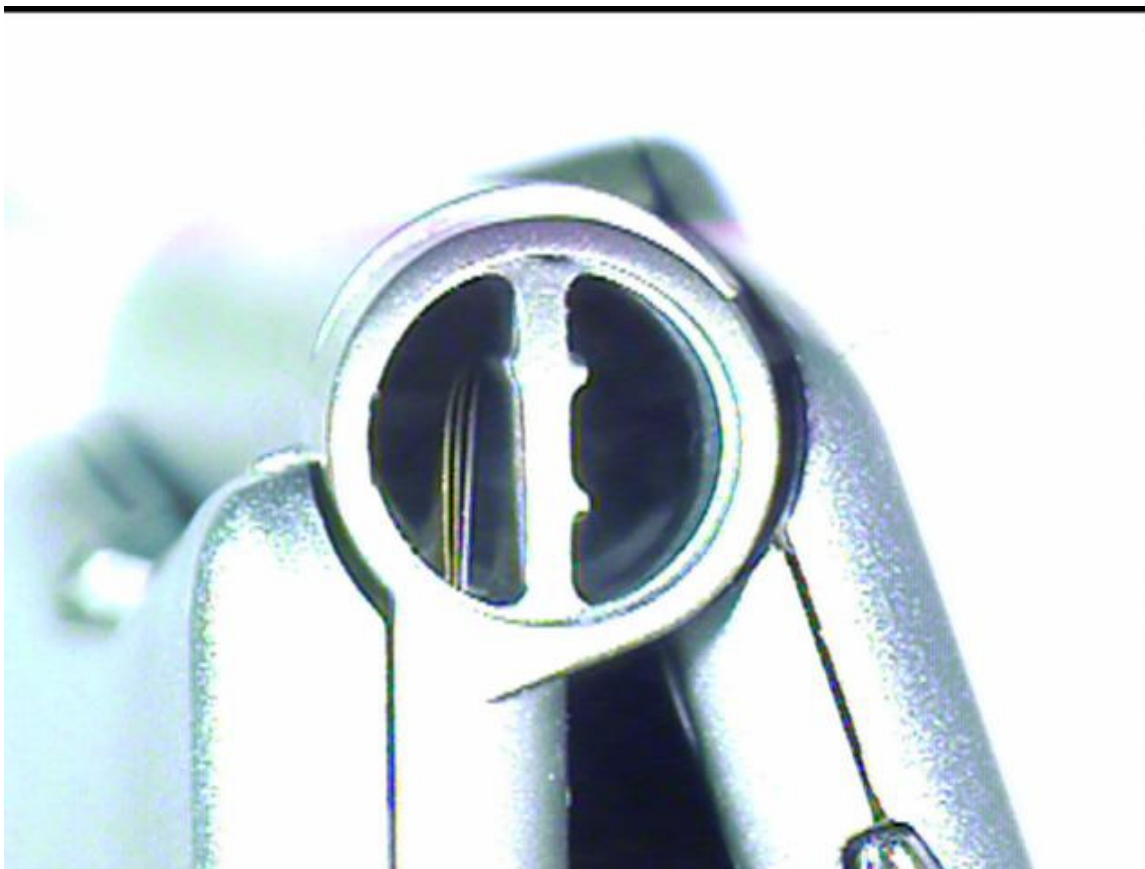
The NA service team has reported a V3 missing/broken/loose end cap issue causing field returns.

When servicing GSM RAZR customer returns with the describe failure the end cap must be replace with a new one. Part # 1589126Y01

Service center must NOT reuse the end cap.

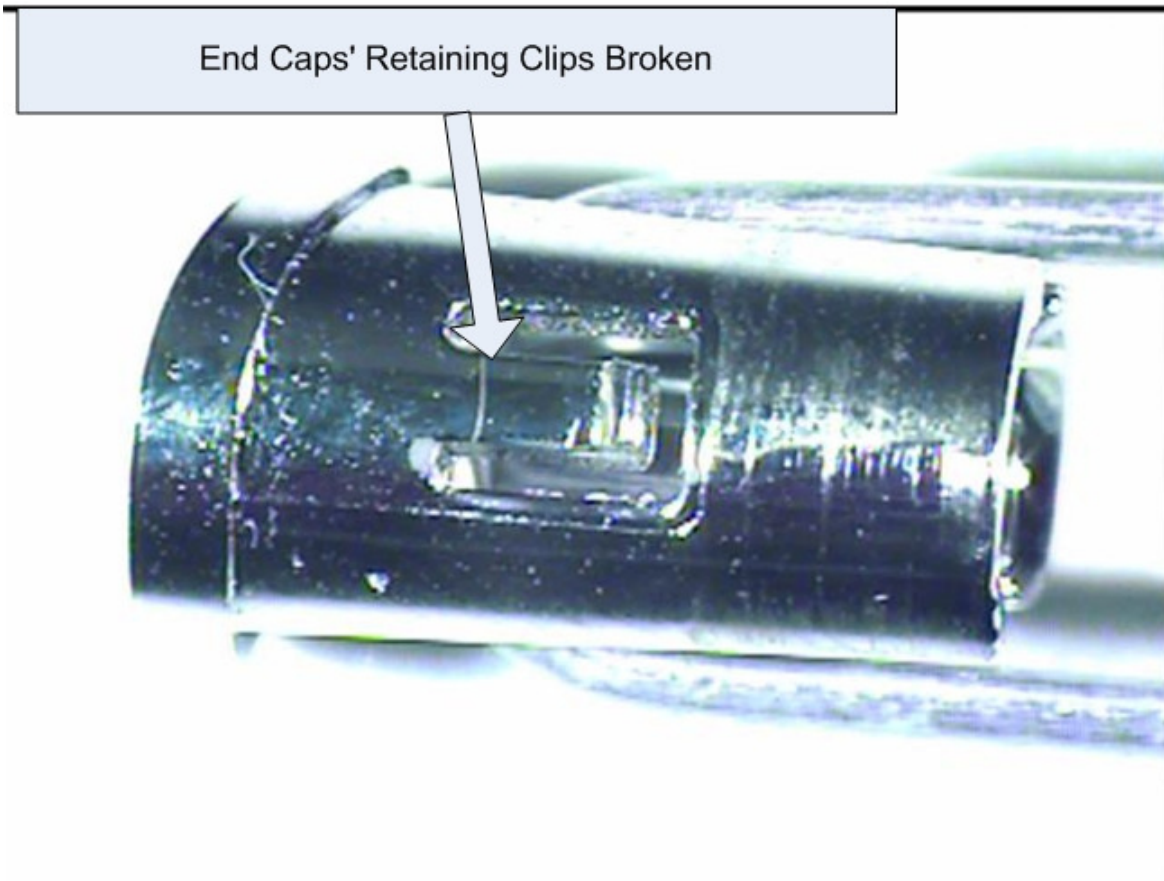
The root cause was determined to be end caps' retaining clips getting damaged after disassembly, which were then reused during factory rework and service refurbishment.

The end cap was originally determined to be non-reusable after disassembly. The factory SOP was changed to ensure this part is scrap after disassembly.
