CSB-1109-2  
Country : UK  
Date : 11/13/2006  
APC : ALL  
Repair Level : 2

Title V3V3 05 CR - GSM - Speakerphone Metallic FM  
Model Effected V3 & V3\_05

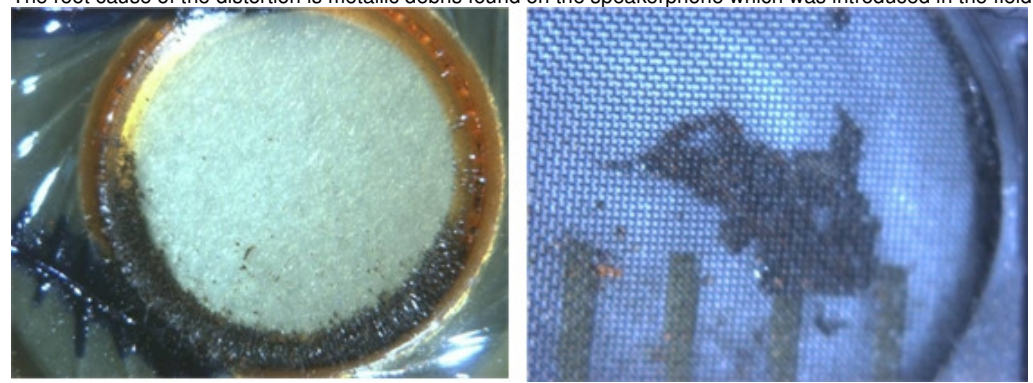
Service has been made aware of a Razr GSM (V3 & V3\_05) speakerphone distortion issue causing "Alert" complaints.

The root cause of the distortion is metallic debris found on the speakerphone which was introduced in the field.

After servicing any Razr GSM (V3 & V3\_05) customer phones with described issue replace the speakerphone and the rear housing with the new mesh if available.  
Speakerphone part number: 5088017N02  
Rear Housing part number: 1590048Nxx

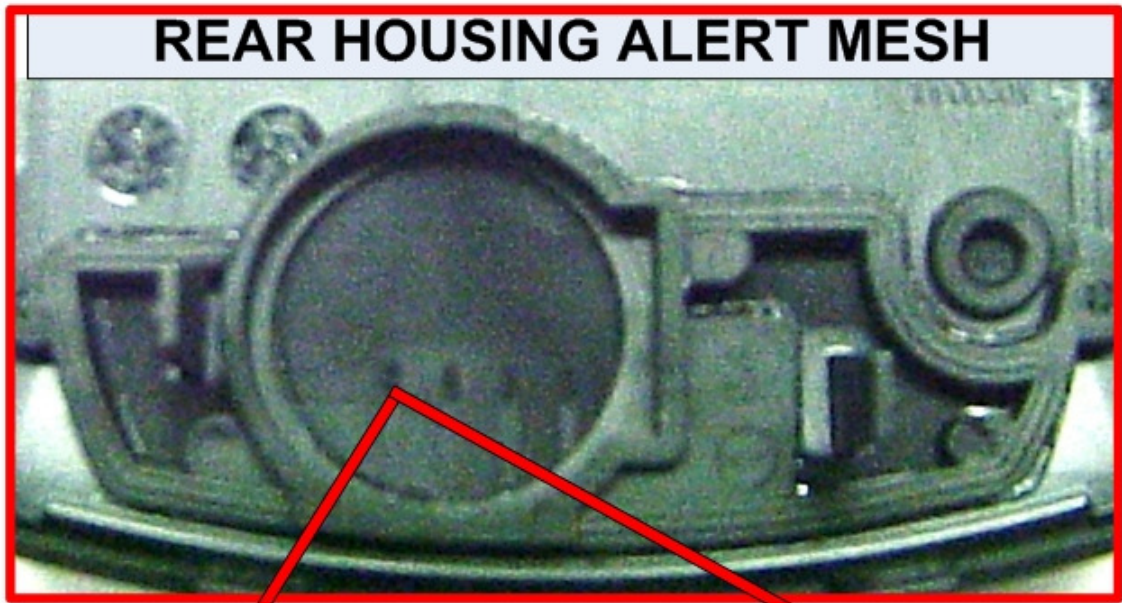
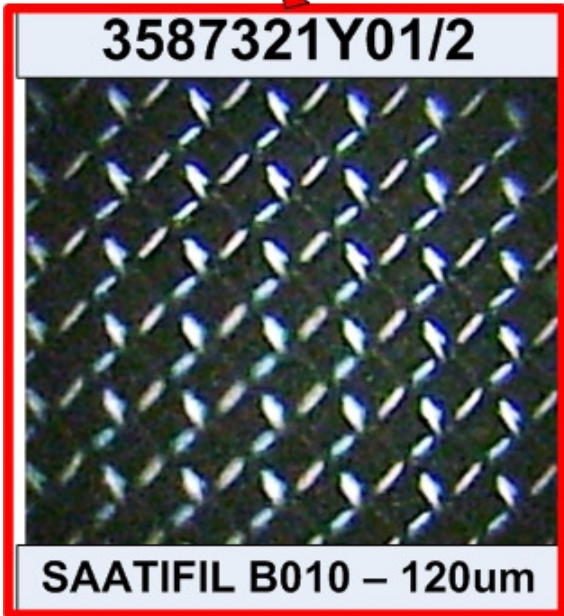
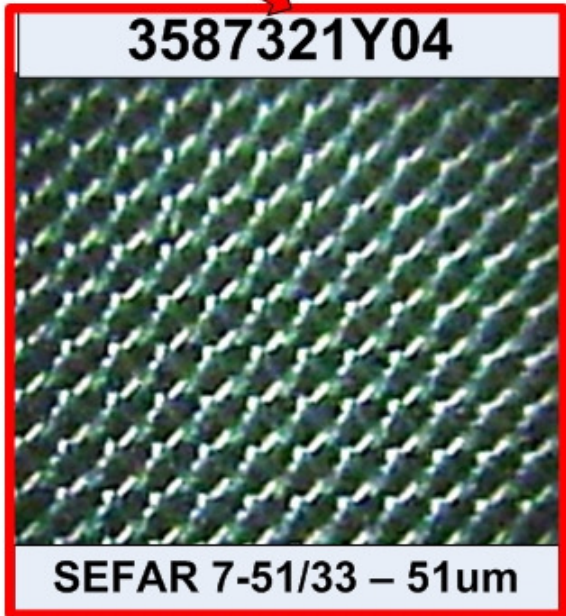
To improve the FM ingress from the rear housing mesh to the speaker phone, the pore size of the mesh was reduce from 120um (micron) to 51um.  
The part number change from 3587321Y01/2 to 3587321Y04.
