CSB-1181-2 Country: UK Date: 2/2/2007 APC: ALL Repair Level: 2

RAZR V3iV3 05 CR - GSM - Battery Contact Short - Kapton Tape V3i & V3_05 $\,$

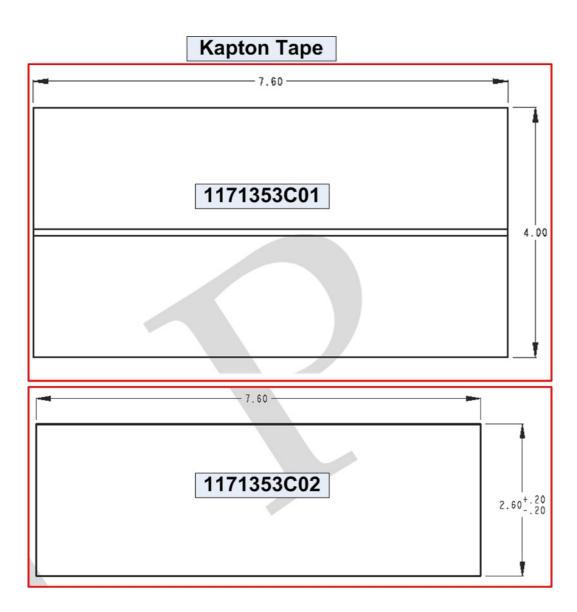
Battery connector pins are being shorted to shield when the phone is dropped from short distance causing a power down. The protective kapton tape placed on the shield start to peel off over time, which gives the opportunity for pins 1 (BATTP) & 2 (OWB) to get under the kapton tape and shorting with the shield.

SOLUTION
The width of the kapton tape was decreased from 4.00mm to 2.60mm and it will only be placed on the side of the shield to prevent the pins from contacting it.
Old Part Number: 1171353C01
New Part Number: 1171353C02
