CSB-1369-1
 Country : UK
 Date : 6/20/2007
 APC : D54
 Repair Level : 1

RAZR V3iV3V3 05 CRV3i / V3e - GSM - Leather Case Magnet Disturbs Hall Effect Sensor
 All

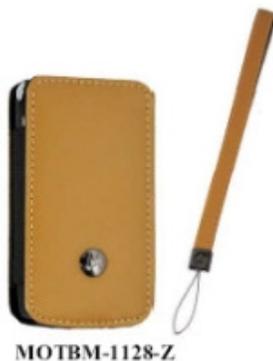
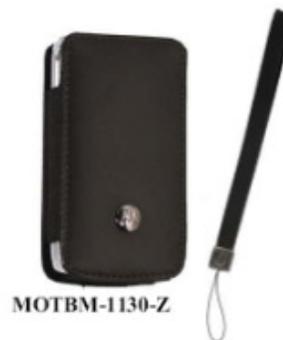
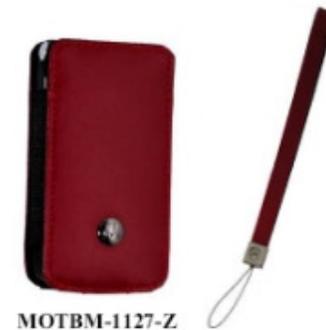
Service Engineering is aware aware of an issue with some leather cases where the phone is answering and/or ending the call itself while taking the phone out of the leather case.

The cases are produced under license by Forward Innovations, marked with Motorola batwings and advertised as 'Motorola Original Accessories'.

There are 4 kit numbers from Forward Innovations affected, containing cases in different color variations (MOTBM-1127, MOTBM-1128, MOTBM-1129, MOTBM-1127).

Please quarantine all existing stock of this leather cases until you get further information how to handle them.

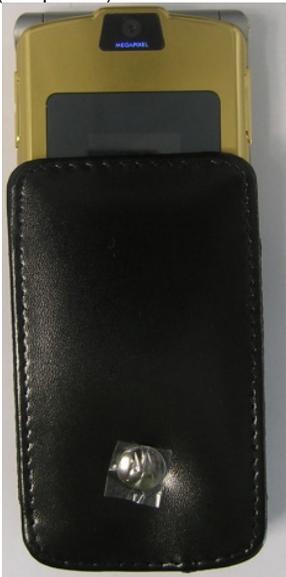
1. Verify if the customer used a leather case like listed above.
 - a) If not, perform normal troubleshooting techniques for these types of customer complaints listed above.
2. Try to reproduce the issue:
 1. Inserting the phone into the leather case (phone flip directed to the leather case top. (see picture)
