FIELD SERVICE BULLETIN

FSB Number: LVCCFSB2006 – 204 Rev (A)

Subject: 3G V3x – Camera Lens Lifting

Phone Models: 3G V3x

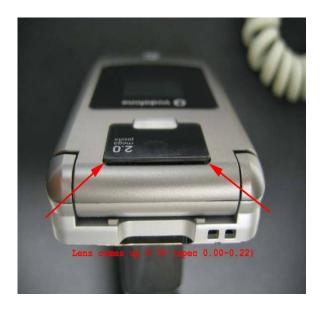
Service is aware of an issue on the V3x where the 2mp camera lens is lifting; above flip outer surface significantly, in excess of cosmetic specification of 0.22mm, see Fig 1. Analysis revealed excessive force applied on the camera lens adhesive. Contributors to the force are the thickness (1.0mm) and density (9 pounds) of the poron camera gasket and the flip housing date code height, which exceeded the specification.

Fig. 1 Camera Lens Lifting

- Replace closed gasket with the open cell gasket (PN 3271688B04) following 2MP LENS REMOVAL PROCEDURE and 2MP LENS PLACEMENT as described below.
- 2. Follow normal post repair testing procedures.
 - a. Verify no contamination between imager and imager lens.
 - b. Test external imager for foreign material in view finder.

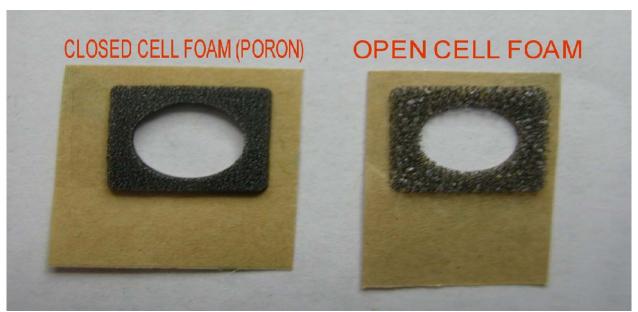
Fig 4. Closed and Open Cell Foam

Production material shipped from Foxconn Feb 21 and beyond will consist of Open Cell Gasket for 2mp camera gasket (3271688B04), see fig. 4
