## FIELD SERVICE BULLETIN

FSB Number: LVCCFSB2006 - 159  
Author: Eduardo Rodriguez  
Date: April 14, 2006  
Total No. of Pages: 4  
Subject: **3G V3x – Hall Effect Switch Sensitivity**  
Phone Models: 3G V3x  
Level of Repair: 2

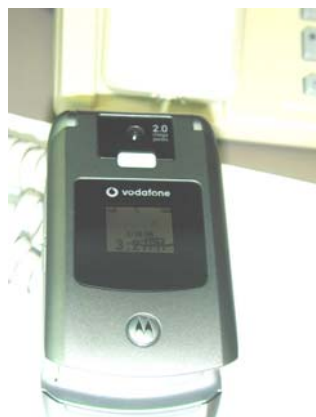
Fig. 1

Service is aware of an issue, identified during the V3x NPI returns. Customer returned units with complaints of “CLI Backlight not working”, “Intermittent CLI Display”, and “Dropped Calls While Opening the Flip.” Analysis revealed one of the flip screws, located precisely above the hall-effect sensor, deforms the flux field around the magnet and decreases the ability of the hall-effect sensor to detect the magnet. This in turn prevents the CLI display from working properly when closing, moving or shifting the flip assembly. On failed units, at approx. 10° (before closing flip), the backlight turned off and the wallpaper changed to carrier logo (barely visible), see fig 1, 2 and 3.

Figs 1-3 CLI ON with wallpaper. CLI OFF and CLI OFF with carrier logo instead of wallpaper (changed from wallpaper to logo when CLI turns OFF)

1. Verify issue by closing the flip, applying pressure to the sideways of flip assembly, shifting or moving it sideways, see figs 1 - 3.
2. If issue is duplicated, replace the lower right hand screw on units manufactured prior 2/1/2006, see fig 5.
3. Upon changing the screw, verify issue does not re-occur.

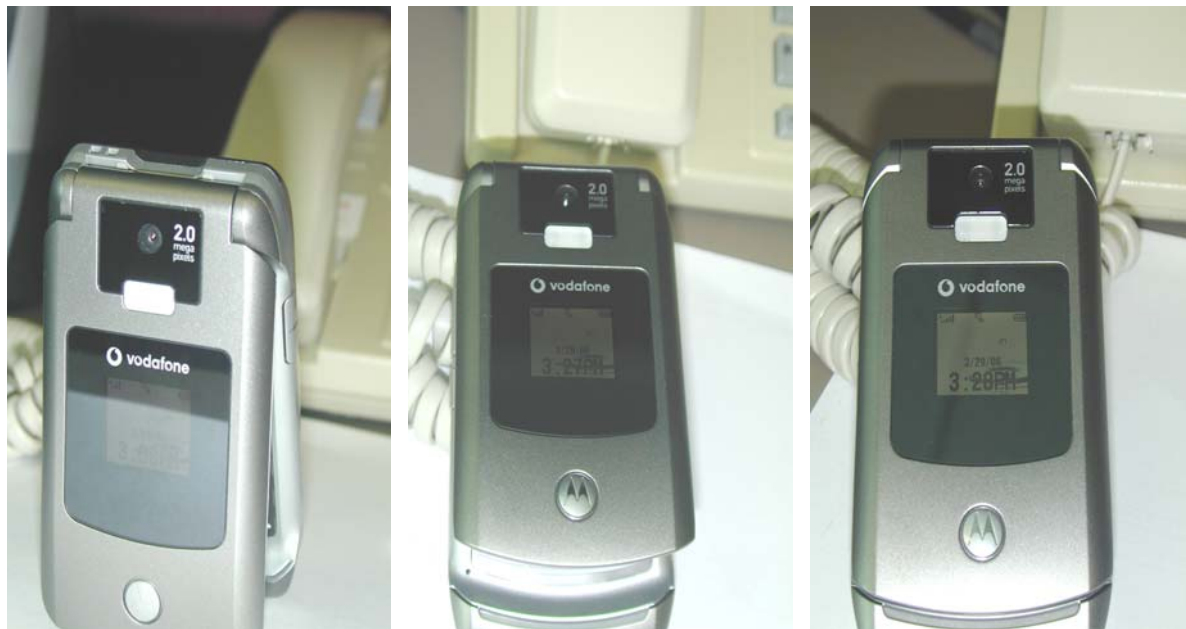
Fig. 4 Normal CLI operation

Under normal operation, the CLI backlight should turn on when closing the flip. The light should illuminate at approx. 35° angle and remain on, with flip closed. The light will then time out. (Time out is dependant on Settings and Carrier). Throughout this operation,

the wallpaper should remain the same. Wallpaper should not change to carrier logo, see fig 4.

CLI on with flip open at 35° CLI on, ~ 10° before closing

CLI on with flip closed
