FIELD SERVICE BULLETIN

FSB Number: LVCCFSB2006- 280
Author: Eduardo Rodriguez
Date: June 7, 2006
Total No. of Pages: 2
Subject: 3G V3x – Protective Clear Liner Obstructing Earpiece
Phone Models: 3G V3x
Level of Repair: 1

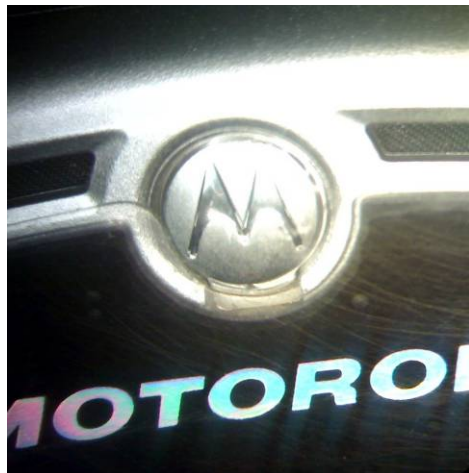
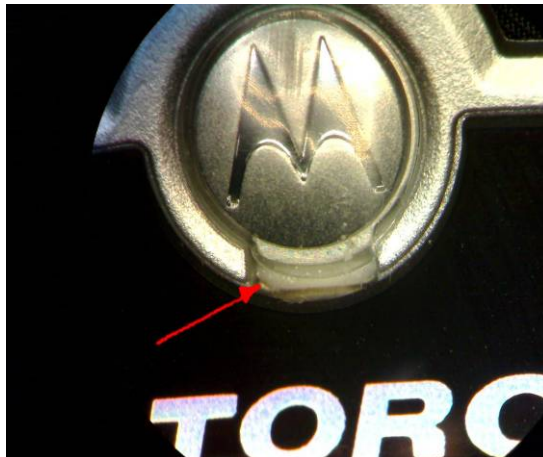
This is an informational bulletin to notify Call Center and Service Center regarding Low Audio. Customers may complain of low or no audio earpiece. Analysis revealed the plastic, clear, protective film covered the earpiece active port. See Fig 1.

Fig.1 Clear Plastic Protective Film Covering Earpiece

Educate the customer to remove the plastic protective film before using the phone.

- 1) Remove protective Plastic Film.
- 2) Follow normal troubleshooting procedures for customer complaints related to Audio.

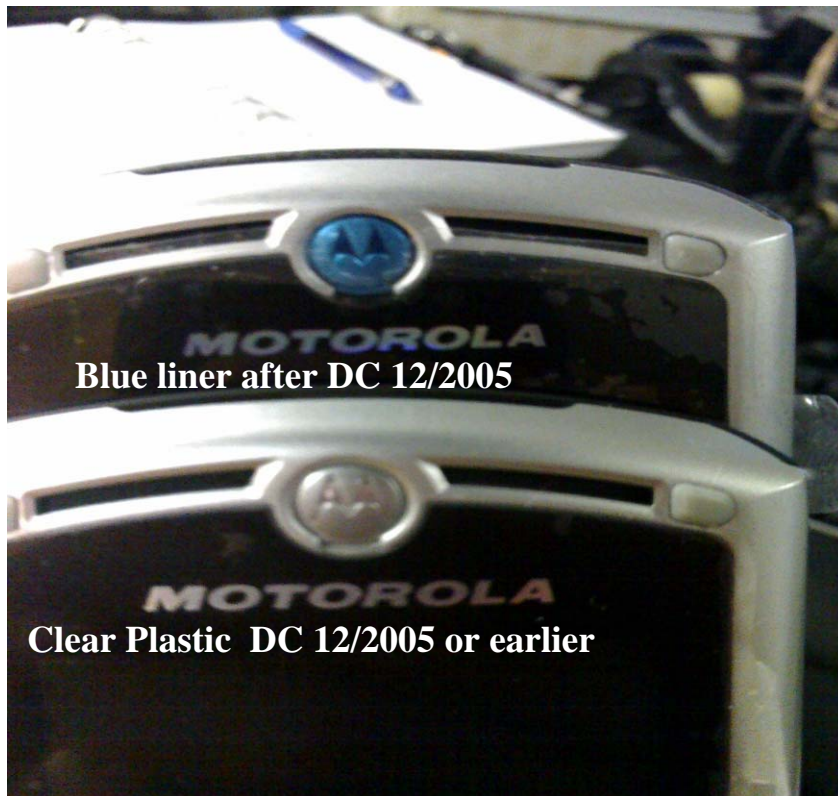
Blue liner application, over the flip earpiece Moto logo, was implemented by Foxconn in 122005, see fig 2.

Fig. 2 Protective Plastic Color Implementation
