FIELD SERVICE BULLETIN

FSB Number: LVCCFSB2006-31
Author: Ross Karlen
Date: February 1, 2006
Total No. of Pages: 3
Subject: **3G E1070, E770v, V3x – Headset Not Recognized**
Model Affected: Friwo Charger SPN5202A and SPN5202B
Level of Repair: 1

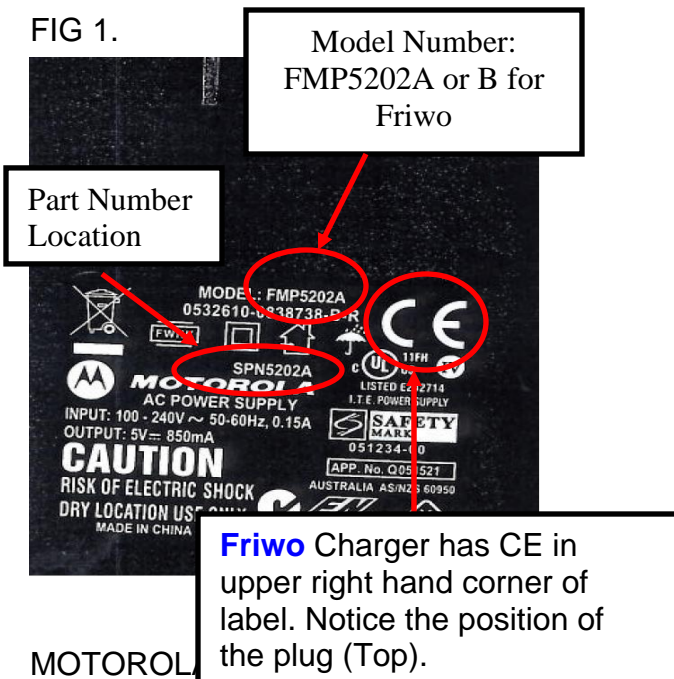
FIG 1.

Service is aware of an issue, highlighted by the carrier on V3x. During initial testing it was found that under certain conditions the Audio Headset would not be recognized when plugging into the USB port on the phone. Analysis revealed the issue to be linked to the state of the ID on Friwo Chargers (SPN5202A and SPN5202B see FIG1) as read by the SW on charger insertion. The state of the ID pin read is not consistent since it has not reached a stable value prior to being read by SW. Sometimes it is floating and sometimes it is grounded, but neither of these states is correct. If the state is read as floating, the headset would work on subsequent insertion. If the state of the read is grounded, then the headset will not work. This issue only occurs with the Friwo charger, not with the Phihong charger.

Short Term: Friwo chargers (FIG 1. SPN5202A and SPN5202B) are quarantined, started shipping with Phihong charger (FIG 2. SPN5202A). NOTE: Need to identify by location of the CE on the charger label.

Note: If software approved in your region is not later than the software with the fix, you must verify the customer's charger is a Friwo Charger (SPN5202A/SPN5202B) and replace it with a Phihong charger (SPN5052A). See images above for identification.

Do not use Friwo chargers (SPN5052A and SPN5052B) as replacements on the models listed above. Please replace with Phihong chargers (SPN5052A). Please see images above on how to determine the difference between the vendors as the part numbers are the same.
