FIELD SERVICE BULLETIN

FSB Number: LVCCFSB2006-98 Rev(A)
Author: Eduardo Rodriguez
Date: March 10, 2006 (Updated March 30, 2006)
Total No. of Pages: 3
Subject: **3G V3x – 5571967B01- Hinge Cam – Difficulty opening and closing flip**
Phone Models: 3G V3x
Level of Repair: 2

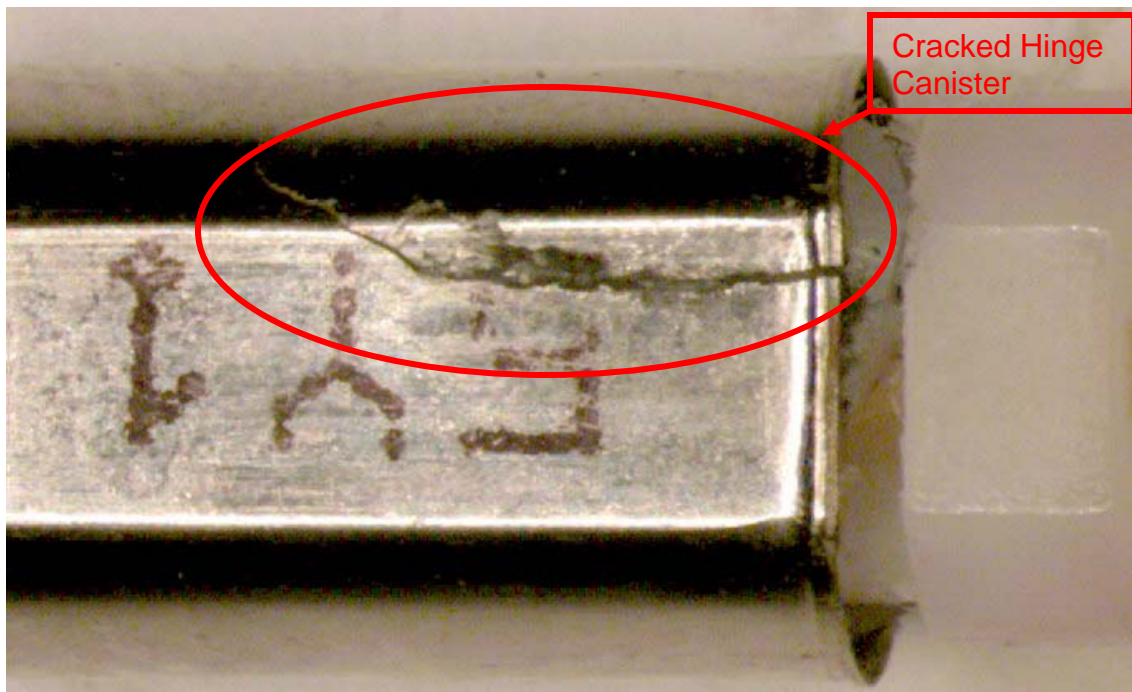
Service is aware of an issue; identified by the field on V3x. Units were returned with a customer complaint of “Difficult opening and closing the flip.” Analysis revealed the hinge canister (Part # 5571967B01) to be cracked due to its thin wall design. (See Fig. 1) The flip becomes difficult to open as the material inside the canister wears and then starts to rotate within the canister, see Fig 2.

- a. Part change to 5571967B03, date code 634 or later – Increased wall thickness and changed from brass to stainless steel material. See fig. 3 on how to read date code.

1. Confirm the customer complaint is due to a cracked or damaged hinge canister (Part # 5571967B01) via normal troubleshooting techniques.
2. Replace the 5571967B01 with 5571967B03, date code of 634 or later.
3. If unit still exhibits symptoms, then follow normal troubleshooting techniques per the customer complaint.

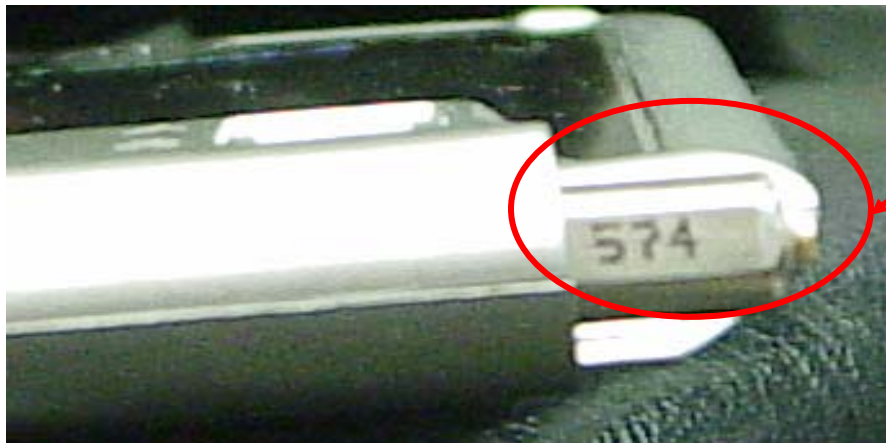
Fig. 3 Date Code on Hinge Canister

5 = Year
7 = Month
4 = Week
